# Access Compliance Report

## Public Rights-of-Way

| Intersection ID: 27907 | Main Street: BAY_HILL_CLUB_DR | Cross Street: COLONIAL_COUNTRY_LN | Location: S |
| ADA ID: B8E057954404 | Ramp Type: Perp | Initial Pass/Fail: Fail | Overall Compliance: No |

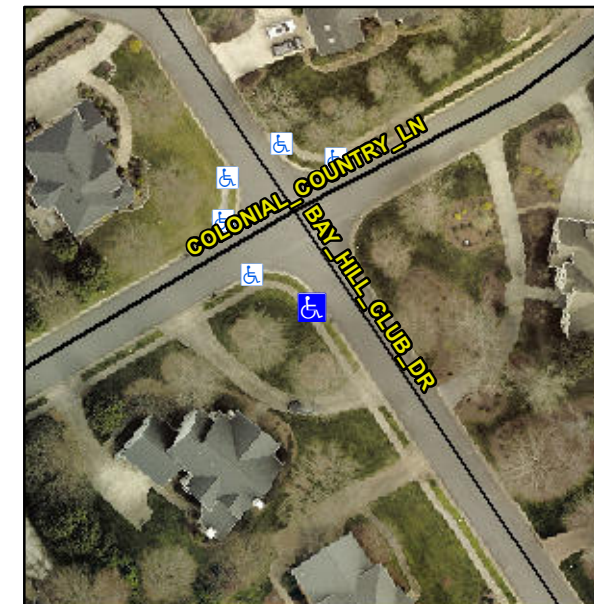
**Not Found, R304.2.2**

| Compliance | Description | Data | Compliance | Description | Data |
|---|---|---|---|---|---|
| N/A | Ramp Length (in) | 50.0 | No | Ramp Slope (%) | 12.5 |

**Remove & Replace Entire Ramp.**
