Access Compliance Report

Public Rights-of-Way

(Curb Ramps)

Intersection ID: 48516	Main Street: GALLERIA CLUB LN	Cross Street: GALLERIA BV	Location: NW
ADA ID: B9206C578A75	Ramp Type: PerpDiag	Initial Pass/Fail: Fail	Overall Compliance: No
Severity Score: 21.25			
Codes/Mitigation Info/Possible Solution		Field Measurements/Component Compliance

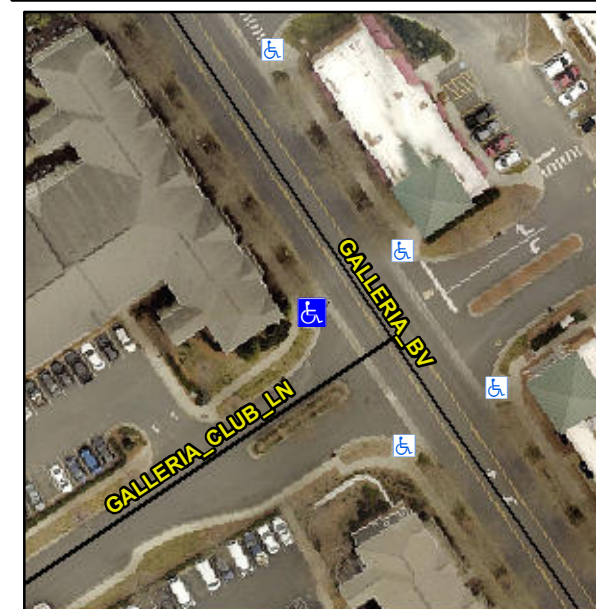
R304.5.1, R304.5.3

Compliance	Description	Data	Compliance	Description	Data
N/A	Ramp Length (in)	94.0	Yes	Ramp Slope (%)	7.2
No	Ramp Width (in)	39.0	No	Ramp XSlope (%)	5.6
N/A	Flare Type LT	N/A	N/A	Flare Type RT	N/A
N/A	Flare Slope LT (%)	N/A	N/A	Flare Slope RT (%)	N/A
N/A	Flare Traversable LT?	N/A	N/A	Flare Traversable RT?	N/A
N/A	Landing Length (in)	N/A	N/A	DWS Provided?	N/A
N/A	Landing Width (in)	N/A	N/A	DWS Contrast?	N/A
N/A	Landing Slope (%)	N/A	N/A	DWS Length (in)	N/A
N/A	Landing X Slope (%)	N/A	N/A	DWS Full Width?	N/A
N/A	Landing Curb? (Y/N)	N/A	N/A	DWS Offset (in)	N/A
N/A	Shared Landing?	N/A			
N/A	Gutter Ponding?	N/A	N/A	Gutter Slope (%)	N/A
N/A	Gutter Lip Ht (in)	N/A	N/A	Gutter X Slope (%)	N/A
N/A	Painted X Walk1?	No	N/A	Painted X Walk2?	No
	X Walk 1 Direction	To SE		X Walk 2 Direction	To NE
N/A	X Walk 1 Width (in)	N/A	N/A	X Walk 2 Width (in)	N/A
	X Walk 1 Slope (%)	1.9		X Walk 2 Slope (%)	7.5
	X Walk 1 X Slope (%)	6.3		X Walk 2 X Slope (%)	0.4

N/A	Ramp inside XWalk1?	N/A	N/A	Ramp inside XWalk2?	N/A
	Road Slope (%)	3.9	N/A	Clear Space?	N/A
	Road X Slope (%)	5.2	N/A	Clear Space to XWalk (in)	N/A
N/A	Any Obstructions?	N/A	N/A	Storm Grate/Utility Hazard?	N/A
	Obstruction Type			Storm Grate/Utility Type	
		N/A			N/A
			Yes	Surface Condition? (G/P)	Good

Remove & Replace Curb Ramp With Two New Directional Ramps or Equivalent.
