Access Compliance Report Public Rights-of-Way (Curb Ramps)

Intersection ID: 12446 Main Street: ASHLAND_AV Cross Street: BELVEDERE_AV Location: W

ADA ID: B925A870897F Ramp Type: PerpDiag Initial Pass/Fail: Fail Overall Compliance: No Severity Score: 22.5

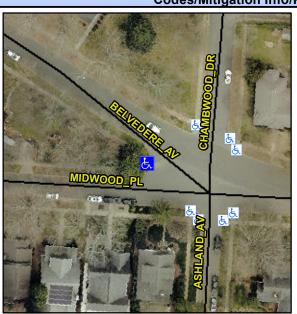
Not Found, R304.5.1, R304.2.2, R304.5.3

Field Measurements/Component Compliance						
	Compl	Compliance Description		Comp	liance Description	Data
	N/A	Ramp Length (in)	99.0	No	Ramp Slope (%)	8.7
	No	Ramp Width (in)	36.0	No	Ramp XSlope (%)	2.1
	N/A	Flare Type LT	N/A	N/A	Flare Type RT	N/A
	N/A	Flare Slope LT (%)	N/A	N/A	Flare Slope RT (%)	N/A
	N/A	Flare Traversable LT?	N/A	N/A	Flare Traversable RT?	N/A
	N/A	Landing Length (in)	N/A	N/A	DWS Provided?	N/A
	N/A	Landing Width (in)	N/A	N/A	DWS Contrast?	N/A
	N/A	Landing Slope (%)	N/A	N/A	DWS Length (in)	N/A
	N/A	Landing X Slope (%)	N/A	N/A	DWS Full Width?	N/A
	N/A	Landing Curb? (Y/N)	N/A	N/A	DWS Offset (in)	N/A
	N/A	Shared Landing?	N/A			
	N/A	Gutter Ponding?	N/A	N/A	Gutter Slope (%)	N/A
	N/A	Gutter Lip Ht (in)	N/A	N/A	Gutter X Slope (%)	N/A
	N/A	Painted X Walk1?	No	N/A	Painted X Walk2?	No
		X Walk 1 Direction	To SE		X Walk 2 Direction	To NE
	N/A	X Walk 1 Width (in)	N/A	N/A	X Walk 2 Width (in)	N/A
		X Walk 1 Slope (%)	0.9		X Walk 2 Slope (%)	0.8

X Walk 1 X Slope (%)	1.1		X Walk 2 X Slope (%)	0.8
	N/A	Ramp inside XWalk1?	N/A	N/A	Ramp inside XWalk2?	N/A
		Road Slope (%)	0.6	N/A	Clear Space?	N/A
		Road X Slope (%)	0.5	N/A	Clear Space to XWalk (in)	N/A
	N/A	Any Obstructions?	N/A	N/A	Storm Grate/Utility Hazard?	N/A
		Obstruction Type			Storm Grate/Utility Type	
			N/A			N/A
				Yes	Surface Condition? (G/P)	Good

Remove & Replace Curb Ramp With Two New Directional Ramps or Equivalent.
