Access Compliance Report

Public Rights-of-Way

(Curb Ramps)

Intersection ID: 28129	Main Street: OLIVIA_LN	Cross Street: ORCHID_PL	Location:	W
ADA ID: B93B0D3293FB	Ramp Type: BlendTrans2	Initial Pass/Fail: Fail	Overall Compliance: No	Severity Score: 35
Codes/Mitigation Info/Possible Solution		Field Measurements/Component Compliance

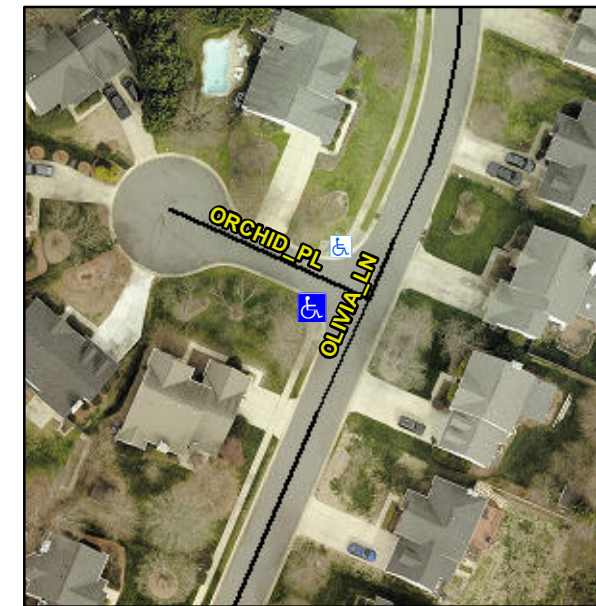
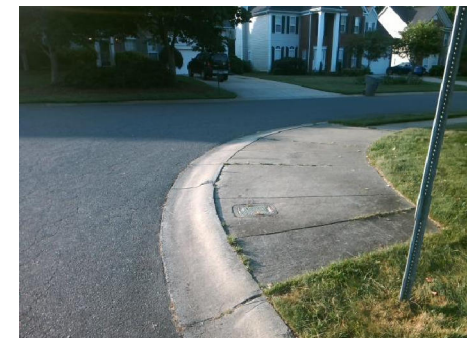
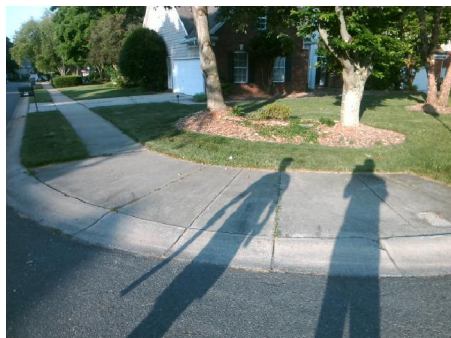
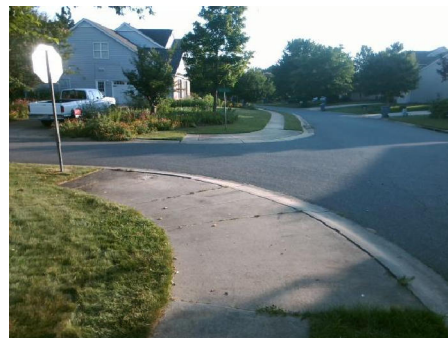
Not Found, R304.5.1

Compliance	Description	Data	Compliance	Description	Data
N/A	Ramp Length (in)	96.5	Yes	BlendTrans Slope (%)	4.2
No	Ramp Width (in)	26.0	Yes	BlendTrans XSlope (%)	1.1
N/A	Flare Type LT	N/A	N/A	Flare Type RT	N/A
N/A	Flare Slope LT (%)	N/A	N/A	Flare Slope RT (%)	N/A
N/A	Flare Traversable LT?	N/A	N/A	Flare Traversable RT?	N/A
N/A	Landing Length (in)	N/A	N/A	DWS Provided?	N/A
N/A	Landing Width (in)	N/A	N/A	DWS Contrast?	N/A
N/A	Landing Slope (%)	N/A	N/A	DWS Length (in)	N/A
N/A	Landing X Slope (%)	N/A	N/A	DWS Full Width?	N/A
N/A	Landing Curb? (Y/N)	N/A	N/A	DWS Offset (in)	N/A
N/A	Shared Landing?	N/A			
N/A	Gutter Ponding?	N/A	N/A	Gutter Slope (%)	N/A
N/A	Gutter Lip Ht (in)	N/A	N/A	Gutter X Slope (%)	N/A
N/A	Painted X Walk1?	No	N/A	Painted X Walk2?	No
	X Walk 1 Direction	To SE		X Walk 2 Direction	To NE
	X Walk 1 Width (in)	N/A		X Walk 2 Width (in)	N/A
	X Walk 1 Slope (%)	3.4		X Walk 2 Slope (%)	3.0
	X Walk 1 X Slope (%)	2.8		X Walk 2 X Slope (%)	2.3

N/A	Ramp inside XWalk1?	N/A	N/A	Ramp inside XWalk2?	N/A
	Road Slope (%)	0.3		Clear Space?	N/A
	Road X Slope (%)	5.1	N/A	Clear Space to XWalk (in)	N/A
N/A	Any Obstructions?	N/A	N/A	Storm Grate/Utility Hazard?	N/A
	Obstruction Type			Storm Grate/Utility Type	
		N/A			N/A
			Yes	Surface Condition? (G/P)	Good
			No	Curb Slope (%)	10.5

Remove & Replace Curb Ramp With Two New Directional Ramps or Equivalent.
