# Access Compliance Report

## Public Rights-of-Way

### (Curb Ramps)

Intersection ID: 45157	Main Street: ROBIN_TERRY_CT	Cross Street: MACVEAN_LN	Location: NW
ADA ID: B9A44408E8BB	Ramp Type: PerpDiag	Initial Pass/Fail: Fail	Overall Compliance: No
Severity Score: 21.25			
Codes/Mitigation Info/Possible Solution		Field Measurements/Component Compliance

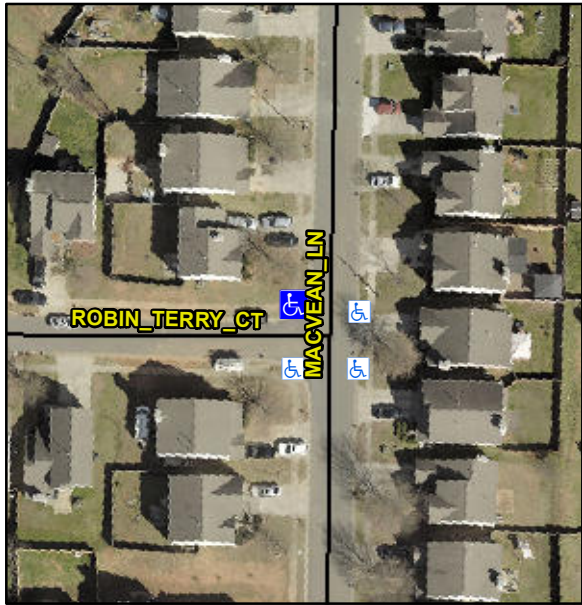
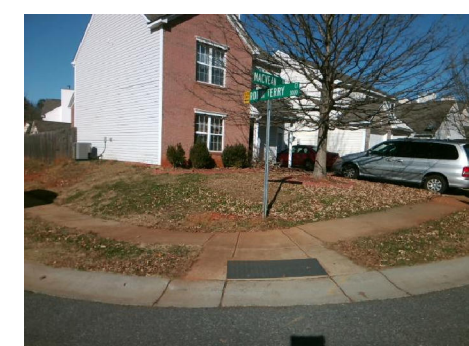
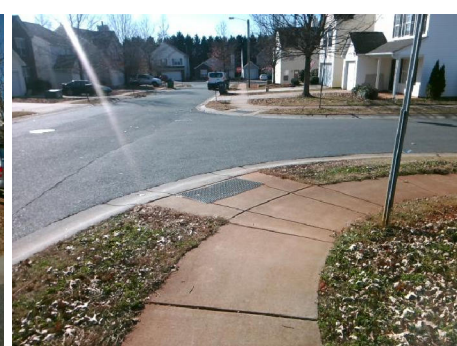
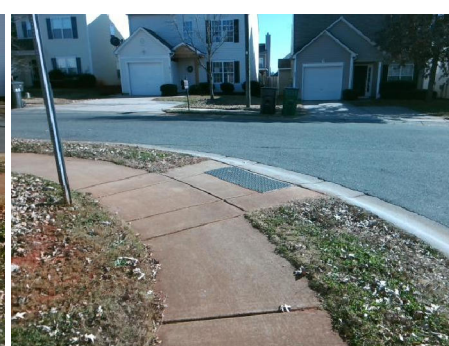
Compliance	Description	Data	Compliance	Description	Data
N/A	Ramp Length (in)	47.5	Yes	Ramp Slope (%)	5.0
No	Ramp Width (in)	38.0	No	Ramp XSlope (%)	6.3
N/A	Flare Type LT	N/A	N/A	Flare Type RT	N/A
N/A	Flare Slope LT (%)	N/A	N/A	Flare Slope RT (%)	N/A
N/A	Flare Traversable LT?	N/A	N/A	Flare Traversable RT?	N/A
N/A	Landing Length (in)	N/A	N/A	DWS Provided?	N/A
N/A	Landing Width (in)	N/A	N/A	DWS Contrast?	N/A
N/A	Landing Slope (%)	N/A	N/A	DWS Length (in)	N/A
N/A	Landing X Slope (%)	N/A	N/A	DWS Full Width?	N/A
N/A	Landing Curb? (Y/N)	N/A	N/A	DWS Offset (in)	N/A
N/A	Shared Landing?	N/A			
N/A	Gutter Ponding?	N/A	N/A	Gutter Slope (%)	N/A
N/A	Gutter Lip Ht (in)	N/A	N/A	Gutter X Slope (%)	N/A
N/A	Painted X Walk1?	No	N/A	Painted X Walk2?	No
	X Walk 1 Direction	To S		X Walk 2 Direction	To E
N/A	X Walk 1 Width (in)	N/A	N/A	X Walk 2 Width (in)	N/A
	X Walk 1 Slope (%)	0.8		X Walk 2 Slope (%)	3.2
	X Walk 1 X Slope (%)	5.7		X Walk 2 X Slope (%)	2.6

N/A	Ramp inside XWalk1?	N/A	N/A	Ramp inside XWalk2?	N/A
	Road Slope (%)	4.8	N/A	Clear Space?	N/A
	Road X Slope (%)	2.9	N/A	Clear Space to XWalk (in)	N/A
N/A	Any Obstructions?	N/A	N/A	Storm Grate/Utility Hazard?	N/A
	Obstruction Type			Storm Grate/Utility Type	
		N/A			N/A
			Yes	Surface Condition? (G/P)	Good

Street 1 Name	ROBIN TERRY CT
	Stop Condition-Street 2	StopSign
	Street 2 Name	MACVEAN LN
	Stop Condition-Street 1	None
	Possible Solutions:	
	Remove & Replace Curb Ramp With Two New Directional Ramps or Equivalent.	
	Surveyor Notes:	
	N/A	
	PROW/ADA:	
	Not Found, R304.5.1, R304.5.3	
Total Cost:		\$ 3200.00
