Access Compliance Report

Public Rights-of-Way

(Curb Ramps)

Intersection ID: 48942	Main Street: MITCHELL GRANT WY	Cross Street: MORGAN LEE AV	Location: SE
ADA ID: B9A96317611A	Ramp Type: Combination2	Initial Pass/Fail: Fail	Overall Compliance: No
Severity Score: 21.25			
Codes/Mitigation Info/Possible Solution		Field Measurements/Component Compliance

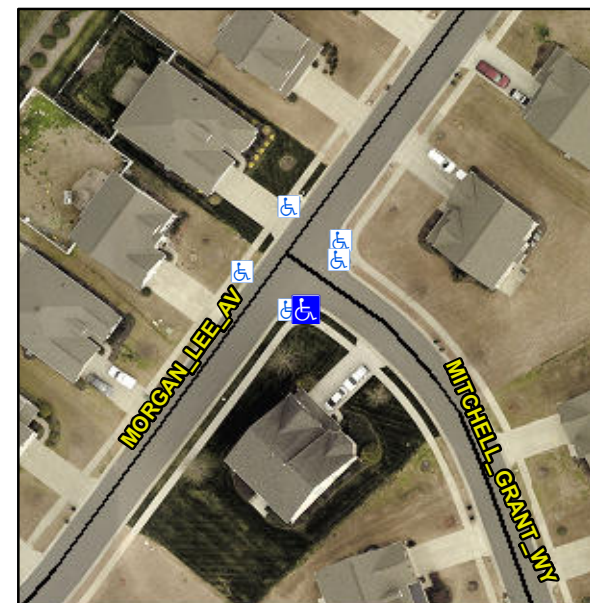
LT RP < 5%

Not Found, R304.5.1, R304.5.3

Compliance	Description	Data	Compliance	Description	Data
N/A	Ramp Length LT (in)	1.0	N/A	Ramp Length RT (in)	8.5
N/A	Ramp Width LT (in)	48.0	No	Ramp Width RT (in)	45.5
N/A	Ramp Slope LT (%)	0.4	Yes	Ramp Slope RT (%)	6.2
N/A	Ramp XSlope LT (%)	3.4	No	Ramp XSlope RT (%)	6.0
N/A	Ramp Length (in)	46.0	Yes	Ramp Slope (%)	7.1
Yes	Ramp Width (in)	48.0	No	Ramp XSlope (%)	3.8
N/A	Flare Type LT	N/A	N/A	Flare Type RT	N/A
N/A	Flare Slope LT (%)	N/A	N/A	Flare Slope RT (%)	N/A
N/A	Flare Traversable LT?	N/A	N/A	Flare Traversable RT?	N/A
N/A	Landing Length (in)	N/A	N/A	DWS Provided?	N/A
N/A	Landing Width (in)	N/A	N/A	DWS Contrast?	N/A
N/A	Landing Slope (%)	N/A	N/A	DWS Length (in)	N/A
N/A	Landing X Slope (%)	N/A	N/A	DWS Full Width?	N/A
N/A	Landing Curb? (Y/N)	N/A	N/A	DWS Offset (in)	N/A
N/A	Shared Landing?	N/A			
N/A	Gutter Ponding?	N/A	N/A	Gutter Slope (%)	N/A
N/A	Gutter Lip Ht (in)	N/A	N/A	Gutter X Slope (%)	N/A
N/A	Painted X Walk1?	No	N/A	Painted X Walk2?	N/A

Remove & Replace Entire Ramp.
