Access Compliance Report Public Rights-of-Way (Curb Ramps)

Intersection ID: 49817 Main Street: ASHLEY_VIEW_DR Cross Street: SIDNEY_CREST_AV Location: W

ADA ID: BA2A0276D522 Ramp Type: PerpDiag Initial Pass/Fail: Fail Overall Compliance: No Severity Score: 8.75

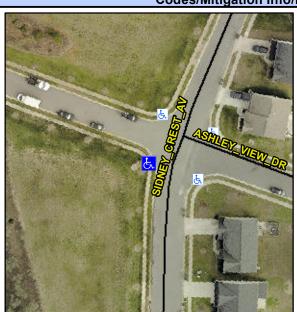
Not Found, R304.5.1

Field Measurements/Component Compliance					
Compliance Description		Data	Comp	oliance Description	Data
N/A	Ramp Length (in)	47.0	Yes	Ramp Slope (%)	7.8
No	Ramp Width (in)	42.5	Yes	Ramp XSlope (%)	0.6
N/A	Flare Type LT	N/A	N/A	Flare Type RT	N/A
N/A	Flare Slope LT (%)	N/A	N/A	Flare Slope RT (%)	N/A
N/A	Flare Traversable LT?	N/A	N/A	Flare Traversable RT?	N/A
N/A	Landing Length (in)	N/A	N/A	DWS Provided?	N/A
N/A	Landing Width (in)	N/A	N/A	DWS Contrast?	N/A
N/A	Landing Slope (%)	N/A	N/A	DWS Length (in)	N/A
N/A	Landing X Slope (%)	N/A	N/A	DWS Full Width?	N/A
N/A	Landing Curb? (Y/N)	N/A	N/A	DWS Offset (in)	N/A
N/A	Shared Landing?	N/A			
N/A	Gutter Ponding?	N/A	N/A	Gutter Slope (%)	N/A
N/A	Gutter Lip Ht (in)	N/A	N/A	Gutter X Slope (%)	N/A
N/A	Painted X Walk1?	No	N/A	Painted X Walk2?	No
	X Walk 1 Direction	To S		X Walk 2 Direction	To N
N/A	X Walk 1 Width (in)	N/A	N/A	X Walk 2 Width (in)	N/A
	X Walk 1 Slope (%)	6.1		X Walk 2 Slope (%)	4.1

X Walk 1 X Slope (%)	1.8		X Walk 2 X Slope (%)	1.9
N/A	Ramp inside XWalk1?	N/A	N/A	Ramp inside XWalk2?	N/A
	Road Slope (%)	1.6	N/A	Clear Space?	N/A
	Road X Slope (%)	6.6	N/A	Clear Space to XWalk (in)	N/A
N/A	Any Obstructions?	N/A	N/A	Storm Grate/Utility Hazard?	N/A
	Obstruction Type			Storm Grate/Utility Type	
		N/A			N/A
			Yes	Surface Condition? (G/P)	Good

Remove & Replace Curb Ramp With Two New Directional Ramps or Equivalent.
