## Access Compliance Report Public Rights-of-Way (Curb Ramps)

Intersection ID: 13911 Main Street: LEXINGTON\_AV Cross Street: ORIOLE\_AV Location: N

ADA ID: BA6BC28F167B Ramp Type: Perp Initial Pass/Fail: Fail Overall Compliance: No Severity Score: 13.75

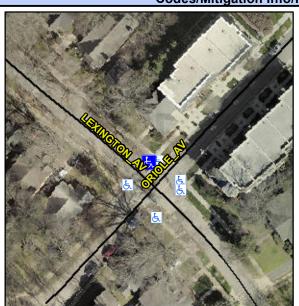
Not Found, R304.2.2, R304.5.3

Field Measurements/Component Compliance					
Compliance Description		Data	Comp	oliance Description	Data
N/A	Ramp Length (in)	76.0	No	Ramp Slope (%)	8.4
Yes	Ramp Width (in)	48.0	No	Ramp XSlope (%)	2.1
N/A	Flare Type LT	N/A	N/A	Flare Type RT	N/A
N/A	Flare Slope LT (%)	N/A	N/A	Flare Slope RT (%)	N/A
N/A	Flare Traversable LT?	N/A	N/A	Flare Traversable RT?	N/A
N/A	Landing Length (in)	N/A	N/A	DWS Provided?	N/A
N/A	Landing Width (in)	N/A	N/A	DWS Contrast?	N/A
N/A	Landing Slope (%)	N/A	N/A	DWS Length (in)	N/A
N/A	Landing X Slope (%)	N/A	N/A	DWS Full Width?	N/A
N/A	Landing Curb? (Y/N)	N/A	N/A	DWS Offset (in)	N/A
N/A	Shared Landing?	N/A			
N/A	Gutter Ponding?	N/A	N/A	Gutter Slope (%)	N/A
N/A	Gutter Lip Ht (in)	N/A	N/A	Gutter X Slope (%)	N/A
N/A	Painted X Walk1?	No	N/A	Painted X Walk2?	N/A
	X Walk 1 Direction	To SW		X Walk 2 Direction	N/A
N/A	X Walk 1 Width (in)	N/A	N/A	X Walk 2 Width (in)	N/A
	X Walk 1 Slope (%)	4.6		X Walk 2 Slope (%)	N/A

Remove & Replace Entire Ramp.
