Access Compliance Report

Public Rights-of-Way

(Curb Ramps)

Intersection ID: 20998	Main Street: CEDAR_RUN_WY	Cross Street: CRESSA_CT	Location: W
ADA ID: BADC9ACCA4D7	Ramp Type: PerpDiag	Initial Pass/Fail: Fail	Overall Compliance: No
			Severity Score: 13.75

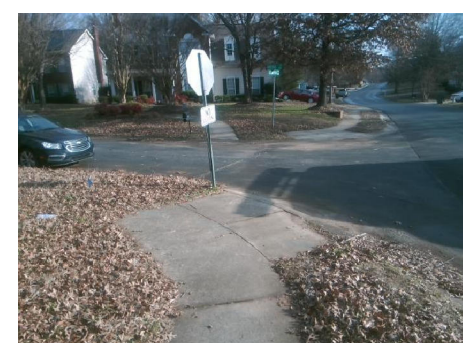
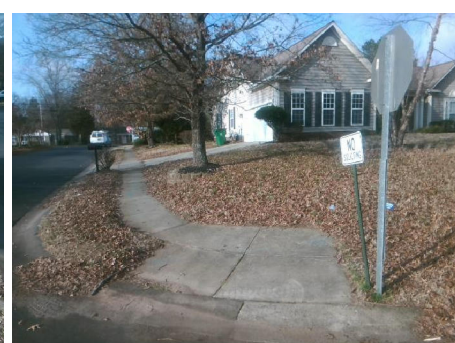
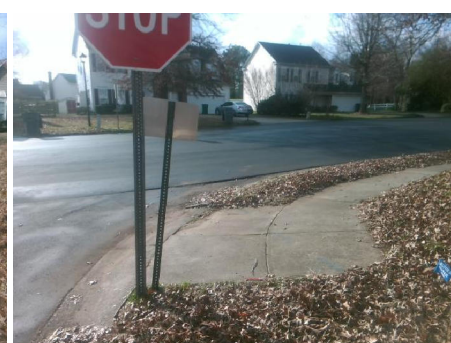
Possible Solutions:		Compliance	Description	Data
	Remove & Replace Curb Ramp With Two New Directional Ramps or Equivalent.		No	Ramp Length (in)	48.0
			Yes	Ramp Width (in)	48.0
			N/A	Flare Type LT	N/A
			N/A	Flare Slope LT (%)	N/A
			N/A	Flare Traversable LT?	N/A
			N/A	Landing Length (in)	N/A
			N/A	Landing Width (in)	N/A
			N/A	Landing Slope (%)	N/A
			N/A	Landing X Slope (%)	N/A
<p>Surveyor Notes:</p> <p>N/A</p> <p>PROW/ADA:</p> <p>Not Found, R304.2.2, R304.5.3</p>			N/A	Flare Type RT	N/A
			N/A	Flare Slope RT (%)	N/A
			N/A	Flare Traversable RT?	N/A
			N/A	DWS Provided?	N/A
			N/A	DWS Contrast?	N/A
			N/A	DWS Length (in)	N/A
			N/A	DWS Full Width?	N/A
			N/A	DWS Offset (in)	N/A
			N/A	Gutter Ponding?	N/A
			N/A	Gutter Lip Ht (in)	N/A
<p>Total Cost:</p> <p>\$ 3200.00</p>			No	Painted X Walk1?	No
			N/A	X Walk 1 Direction	To SE

N/A	X Walk 1 Width (in)	N/A
			0.2	X Walk 1 Slope (%)	0.2
			0.5	X Walk 1 X Slope (%)	2.2
			N/A	Ramp inside XWalk1?	N/A
			0.0	Road Slope (%)	N/A
			0.7	Road X Slope (%)	N/A
			N/A	Any Obstructions?	N/A
			N/A	Obstruction Type	N/A
			N/A	Clear Space?	N/A
			N/A	Clear Space to XWalk (in)	N/A
			N/A	Storm Grate/Utility Hazard?	N/A
			N/A	Storm Grate/Utility Type	N/A
			Yes	Surface Condition? (G/P)	Good
