## Access Compliance Report Public Rights-of-Way (Curb Ramps)

Intersection ID: 10714 Main Street: MULBERRY\_CHURCH\_RD Cross Street: S\_I-85\_EXIT\_33\_RA Location: N/A

ADA ID: BAF64FB68005 Ramp Type: Perp Initial Pass/Fail: Fail Overall Compliance: No Severity Score: 21.25

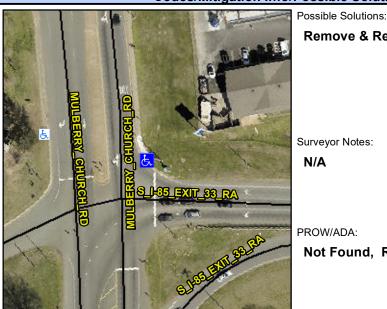
Field Measurements/Component Compliance						
Compliance Description Dat		Data	Compliance Description		Data	
N/A	Ramp Length (in)	60.0	No	Ramp Slope (%)	9.3	
No	Ramp Width (in)	36.0	Yes	Ramp XSlope (%)	1.3	
N/A	Flare Type LT	N/A	N/A	Flare Type RT	N/A	
N/A	Flare Slope LT (%)	N/A	N/A	Flare Slope RT (%)	N/A	
N/A	Flare Traversable LT?	N/A	N/A	Flare Traversable RT?	N/A	
N/A	Landing Length (in)	N/A	N/A	DWS Provided?	N/A	
N/A	Landing Width (in)	N/A	N/A	DWS Contrast?	N/A	
N/A	Landing Slope (%)	N/A	N/A	DWS Length (in)	N/A	
N/A	Landing X Slope (%)	N/A	N/A	DWS Full Width?	N/A	
N/A	Landing Curb? (Y/N)	N/A	N/A	DWS Offset (in)	N/A	
N/A	Shared Landing?	N/A				
N/A	Gutter Ponding?	N/A	N/A	Gutter Slope (%)	N/A	
N/A	Gutter Lip Ht (in)	N/A	N/A	Gutter X Slope (%)	N/A	
N/A	Painted X Walk1?	No	N/A	Painted X Walk2?	N/A	
	X Walk 1 Direction	To W		X Walk 2 Direction	N/A	
N/A	X Walk 1 Width (in)	N/A	N/A	X Walk 2 Width (in)	N/A	
	X Walk 1 Slope (%)	1.0		X Walk 2 Slope (%)	N/A

X Walk 1 X Slope (%)	0.6		X Walk 2 X Slope (%)	N/A	
N/A	Ramp inside XWalk1?	N/A	N/A	Ramp inside XWalk2?	N/A	
	Road Slope (%)	0.6	N/A	Clear Space?	N/A	
	Road X Slope (%)	1.0	N/A	Clear Space to XWalk (in)	N/A	
N/A	Any Obstructions?	N/A	N/A	Storm Grate/Utility Hazard?	N/A	
	Obstruction Type			Storm Grate/Utility Type		
		N/A			N/A	
			Yes	Surface Condition? (G/P)	Good

Possible Solutions.
Remove & Replace Entire Ramp.
Surveyor Notes:
N/A
PROW/ADA:
Not Found, R304.5.1, R304.2.2
Not 1 Julia, 11304.5.1, 11304.2.2
