Access Compliance Report

Public Rights-of-Way

(Curb Ramps)

Intersection ID: 13098	Main Street: S_CHURCH_ST	Cross Street: LINCOLN_ST	Location:	N
ADA ID: BB3D72BBA92F	Ramp Type: PerpDiag	Initial Pass/Fail: Fail	Overall Compliance: No	Severity Score: 25

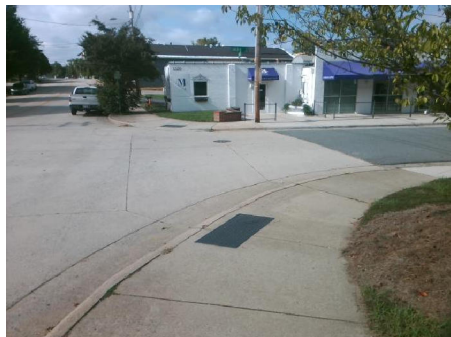
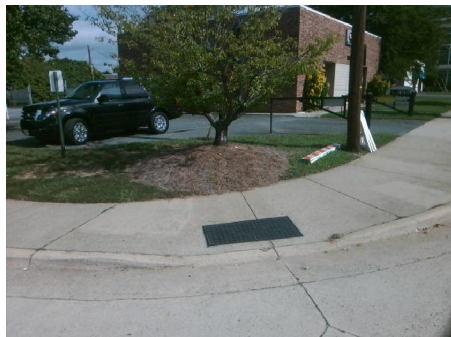
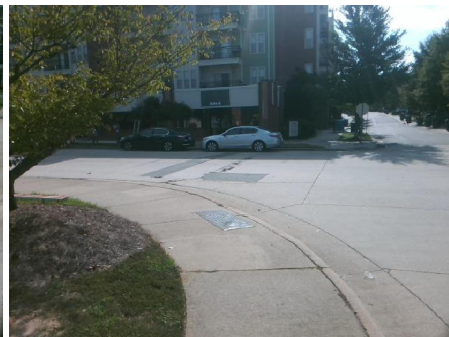
Not Found, R304.2.2, R304.5.3

Compliance	Description	Data	Compliance	Description	Data
N/A	Ramp Length (in)	78.0	No	Ramp Slope (%)	9.0
Yes	Ramp Width (in)	48.0	No	Ramp XSlope (%)	6.3
N/A	Flare Type LT	N/A	N/A	Flare Type RT	N/A
N/A	Flare Slope LT (%)	N/A	N/A	Flare Slope RT (%)	N/A
N/A	Flare Traversable LT?	N/A	N/A	Flare Traversable RT?	N/A
N/A	Landing Length (in)	N/A	N/A	DWS Provided?	N/A
N/A	Landing Width (in)	N/A	N/A	DWS Contrast?	N/A
N/A	Landing Slope (%)	N/A	N/A	DWS Length (in)	N/A
N/A	Landing X Slope (%)	N/A	N/A	DWS Full Width?	N/A
N/A	Landing Curb? (Y/N)	N/A	N/A	DWS Offset (in)	N/A
N/A	Shared Landing?	N/A			
N/A	Gutter Ponding?	N/A	N/A	Gutter Slope (%)	N/A
N/A	Gutter Lip Ht (in)	N/A	N/A	Gutter X Slope (%)	N/A
N/A	Painted X Walk1?	No	N/A	Painted X Walk2?	No
	X Walk 1 Direction	To SW		X Walk 2 Direction	To SE
N/A	X Walk 1 Width (in)	N/A	N/A	X Walk 2 Width (in)	N/A
	X Walk 1 Slope (%)	0.6		X Walk 2 Slope (%)	4.0
	X Walk 1 X Slope (%)	2.9		X Walk 2 X Slope (%)	0.2

N/A	Ramp inside XWalk1?	N/A	N/A	Ramp inside XWalk2?	N/A
	Road Slope (%)	3.0	N/A	Clear Space?	N/A
	Road X Slope (%)	3.8	N/A	Clear Space to XWalk (in)	N/A
N/A	Any Obstructions?	N/A	N/A	Storm Grate/Utility Hazard?	N/A
	Obstruction Type			Storm Grate/Utility Type	
		N/A			N/A
			Yes	Surface Condition? (G/P)	Good

Remove & Replace Curb Ramp With Two New Directional Ramps or Equivalent.
