## Access Compliance Report Public Rights-of-Way (Curb Ramps)

Intersection ID: 51054 Main Street: MULBERRY\_CHURCH\_RD Cross Street: N/A Location: NW

ADA ID: BBC0720CB745 Ramp Type: Perp Initial Pass/Fail: Fail Overall Compliance: No Severity Score: 8.75

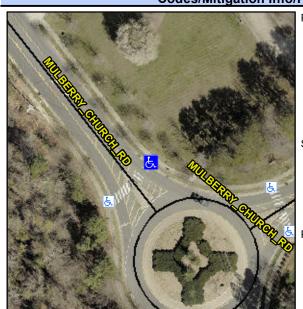
Not Found, R304.5.1

Remove & Replace Entire Ramp.
