# Access Compliance Report

## Public Rights-of-Way

### (Curb Ramps)

Intersection ID: 9305	Main Street: LUCENA_ST	Cross Street: MORETZ_AV	Location: S
ADA ID: BBDA641D6172	Ramp Type: Perp	Initial Pass/Fail: Fail	Overall Compliance: No
Severity Score: 21.25			
Codes/Mitigation Info/Possible Solution		Field Measurements/Component Compliance

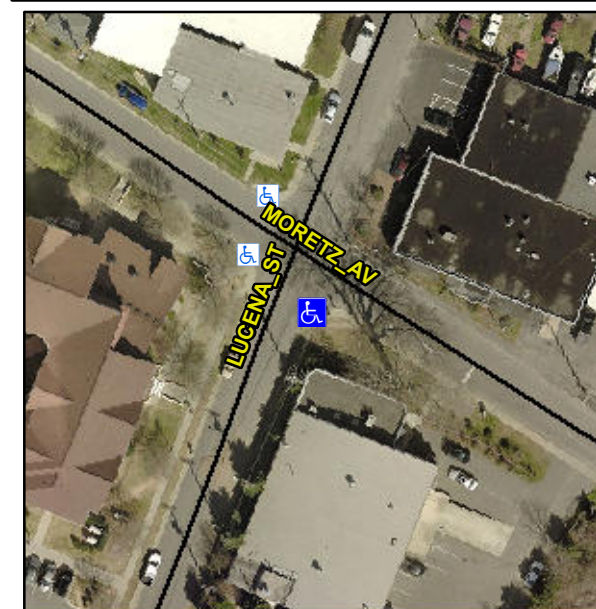
**R304.5.1, R304.5.3**

Compliance	Description	Data	Compliance	Description	Data
N/A	Ramp Length (in)	57.0	Yes	Ramp Slope (%)	7.6
No	Ramp Width (in)	38.0	No	Ramp XSlope (%)	5.3
N/A	Flare Type LT	N/A	N/A	Flare Type RT	N/A
N/A	Flare Slope LT (%)	N/A	N/A	Flare Slope RT (%)	N/A
N/A	Flare Traversable LT?	N/A	N/A	Flare Traversable RT?	N/A
N/A	Landing Length (in)	N/A	N/A	DWS Provided?	N/A
N/A	Landing Width (in)	N/A	N/A	DWS Contrast?	N/A
N/A	Landing Slope (%)	N/A	N/A	DWS Length (in)	N/A
N/A	Landing X Slope (%)	N/A	N/A	DWS Full Width?	N/A
N/A	Landing Curb? (Y/N)	N/A	N/A	DWS Offset (in)	N/A
N/A	Shared Landing?	N/A			
N/A	Gutter Ponding?	N/A	N/A	Gutter Slope (%)	N/A
N/A	Gutter Lip Ht (in)	N/A	N/A	Gutter X Slope (%)	N/A
N/A	Painted X Walk1?	No	N/A	Painted X Walk2?	N/A
	X Walk 1 Direction	To NW		X Walk 2 Direction	N/A
N/A	X Walk 1 Width (in)	N/A	N/A	X Walk 2 Width (in)	N/A
	X Walk 1 Slope (%)	0.4		X Walk 2 Slope (%)	N/A
	X Walk 1 X Slope (%)	2.7		X Walk 2 X Slope (%)	N/A

**Remove & Replace Entire Ramp.**

Total Cost: \$ 1850.00
