# Access Compliance Report

## Public Rights-of-Way

### (Curb Ramps)

| Intersection ID: 11167 | Main Street: BARRY_ST | Cross Street: EVERETT_PL | Location: SW |

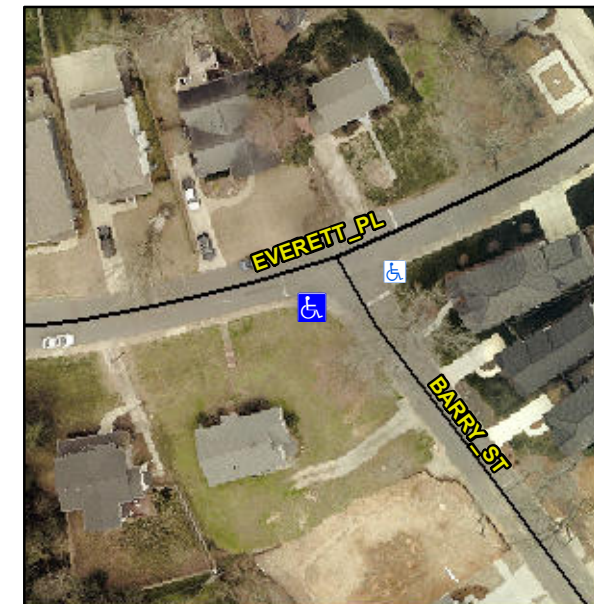
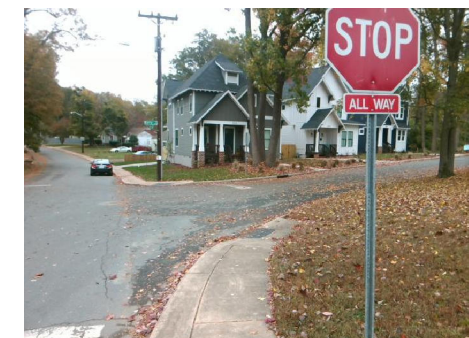
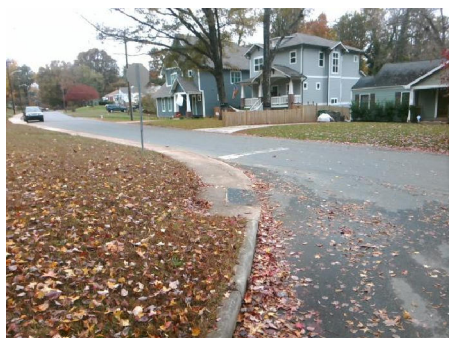
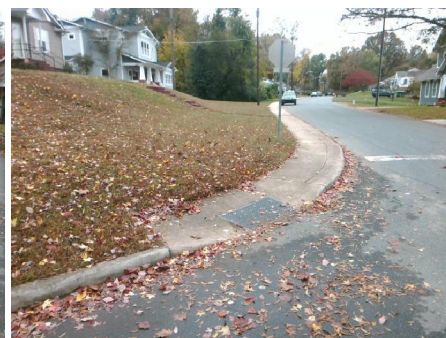
**R304.5.1, R304.2.2, R304.5.3**

| Compliance | Description | Data | Compliance | Description | Data |
|---|---|---|---|---|---|
| N/A | Ramp Length (in) | 53.0 | No | Ramp Slope (%) | 13.5 |
| No | Ramp Width (in) | 46.0 | No | Ramp XSlope (%) | 4.3 |

**Remove & Replace Entire Ramp.**
