# Access Compliance Report

## Public Rights-of-Way

### (Curb Ramps)

| Intersection ID: 42803 | Main Street: BACK_ACRE_DR | Cross Street: SAWMILL_TRACE_DR | Location: NE |

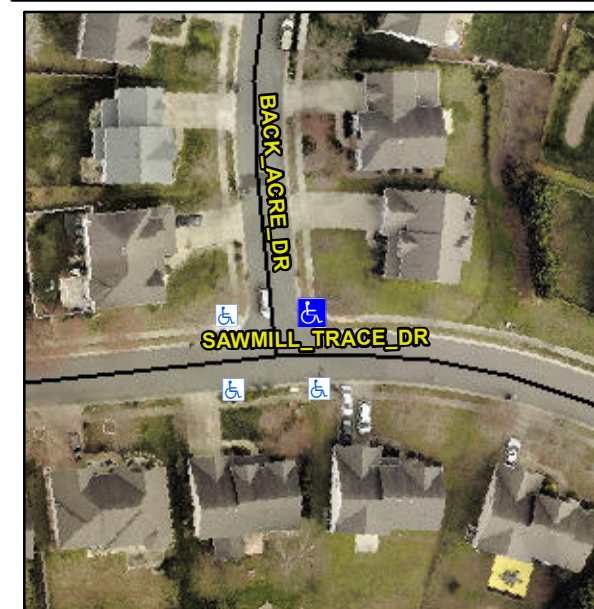
| ADA ID: BC2D932EEE21 | Ramp Type: PerpDiag | Initial Pass/Fail: Fail | Overall Compliance: No |

**Not Found, R304.5.1**

| Compliance | Description | Data | Compliance | Description | Data |
|---|---|---|---|---|---|
| No | Ramp Width (in) | 47.5 | Yes | Ramp XSlope (%) | 1.7 |

**Remove & Replace Curb Ramp With Two New Directional Ramps or Equivalent.**
