Access Compliance Report

Public Rights-of-Way

(Curb Ramps)

Intersection ID: 46817	Main Street: ARBOR_VISTA_DR	Cross Street: HOLM_OAK_PL	Location: SE
ADA ID: BC3EDDFF6D29	Ramp Type: Perp	Initial Pass/Fail: Fail	Overall Compliance: No
Severity Score: 12.5			
Codes/Mitigation Info/Possible Solution		Field Measurements/Component Compliance

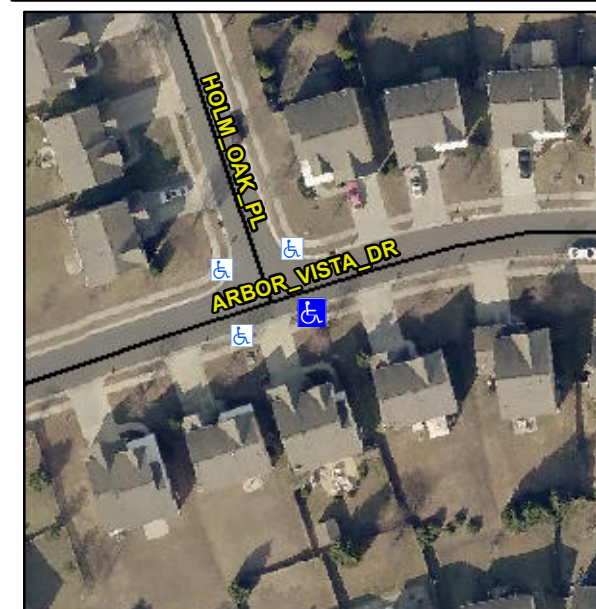
Not Found, R304.2.2

Compliance	Description	Data	Compliance	Description	Data
N/A	Ramp Length (in)	47.0	No	Ramp Slope (%)	9.5
Yes	Ramp Width (in)	51.0	Yes	Ramp XSlope (%)	1.2
N/A	Flare Type LT	N/A	N/A	Flare Type RT	N/A
N/A	Flare Slope LT (%)	N/A	N/A	Flare Slope RT (%)	N/A
N/A	Flare Traversable LT?	N/A	N/A	Flare Traversable RT?	N/A
N/A	Landing Length (in)	N/A	N/A	DWS Provided?	N/A
N/A	Landing Width (in)	N/A	N/A	DWS Contrast?	N/A
N/A	Landing Slope (%)	N/A	N/A	DWS Length (in)	N/A
N/A	Landing X Slope (%)	N/A	N/A	DWS Full Width?	N/A
N/A	Landing Curb? (Y/N)	N/A	N/A	DWS Offset (in)	N/A
N/A	Shared Landing?	N/A			
N/A	Gutter Ponding?	N/A	N/A	Gutter Slope (%)	N/A
N/A	Gutter Lip Ht (in)	N/A	N/A	Gutter X Slope (%)	N/A
N/A	Painted X Walk1?	No	N/A	Painted X Walk2?	N/A
	X Walk 1 Direction	To N		X Walk 2 Direction	N/A
N/A	X Walk 1 Width (in)	N/A	N/A	X Walk 2 Width (in)	N/A
	X Walk 1 Slope (%)	2.7		X Walk 2 Slope (%)	N/A
	X Walk 1 X Slope (%)	2.0		X Walk 2 X Slope (%)	N/A

N/A	Ramp inside XWalk1?	N/A	N/A	Ramp inside XWalk2?	N/A
	Road Slope (%)	N/A	N/A	Clear Space?	N/A
	Road X Slope (%)	N/A	N/A	Clear Space to XWalk (in)	N/A
N/A	Any Obstructions?	N/A	N/A	Storm Grate/Utility Hazard?	N/A
	Obstruction Type			Storm Grate/Utility Type	
		N/A			N/A
			Yes	Surface Condition? (G/P)	Good

Remove & Replace Entire Ramp.
