# Access Compliance Report

## Public Rights-of-Way

### (Curb Ramps)

Intersection ID: 12046	Main Street: S_CEDAR_ST	Cross Street: W_1ST_ST	Location: E
ADA ID: BC76EF8FF68F	Ramp Type: Para	Initial Pass/Fail: Fail	Overall Compliance: No
Severity Score: 13.75			
Codes/Mitigation Info/Possible Solution		Field Measurements/Component Compliance

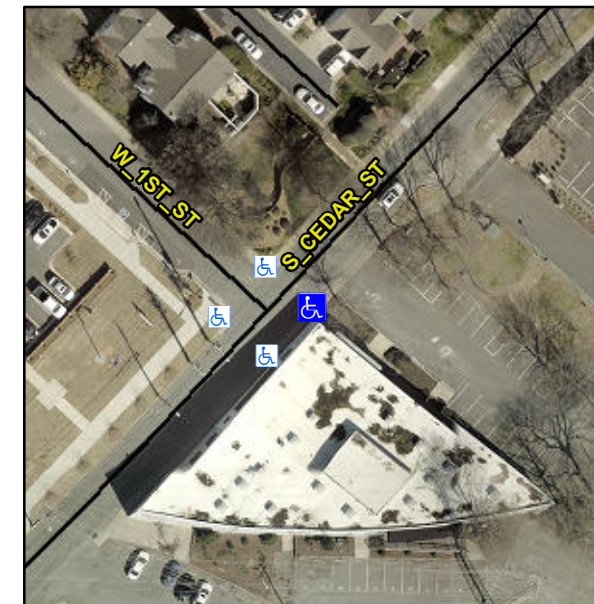
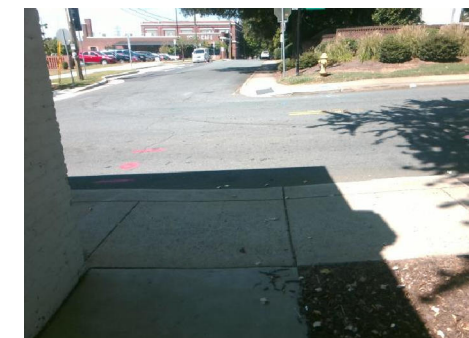
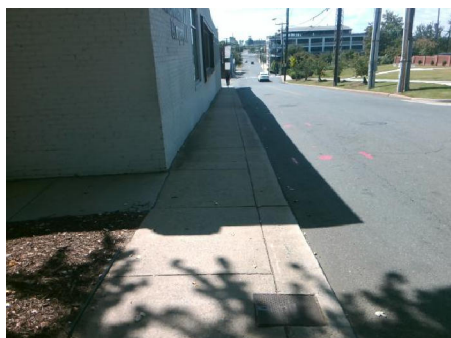
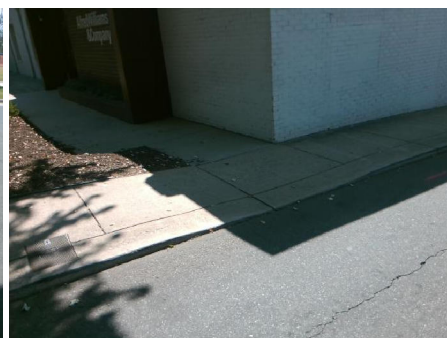
**R304.3.2, R304.5.3**

Compliance	Description	Data	Compliance	Description	Data
N/A	Ramp Length LT (in)	60.0	N/A	Ramp Length RT (in)	60.0
Yes	Ramp Width LT (in)	48.0	Yes	Ramp Width RT (in)	49.0
No	Ramp Slope LT (%)	9.6	Yes	Ramp Slope RT (%)	4.0
No	Ramp XSlope LT (%)	3.7	No	Ramp XSlope RT (%)	2.3
N/A	Landing Length (in)	N/A	N/A	DWS Provided?	N/A
N/A	Landing Width (in)	N/A	N/A	DWS Contrast?	N/A
N/A	Landing Slope (%)	N/A	N/A	DWS Length (in)	N/A
N/A	Landing X Slope (%)	N/A	N/A	DWS Full Width?	N/A
N/A	Landing Curb? (Y/N)	N/A	N/A	DWS Offset (in)	N/A
N/A	Shared Landing?	N/A			
N/A	Gutter Ponding?	N/A	N/A	Gutter Slope (%)	N/A
N/A	Gutter Lip Ht (in)	2.0	N/A	Gutter X Slope (%)	N/A
N/A	Painted X Walk1?	No	N/A	Painted X Walk2?	N/A
	X Walk 1 Direction	To NW		X Walk 2 Direction	N/A
N/A	X Walk 1 Width (in)	N/A	N/A	X Walk 2 Width (in)	N/A
	X Walk 1 Slope (%)	5.4		X Walk 2 Slope (%)	N/A
	X Walk 1 X Slope (%)	5.1		X Walk 2 X Slope (%)	N/A
N/A	Ramp inside XWalk1?	N/A	N/A	Ramp inside XWalk2?	N/A

**Remove & Replace Entire Ramp.**
