Access Compliance Report Public Rights-of-Way (Curb Ramps)

Intersection ID: 20523 Main Street: SOUTH_BV Cross Street: WISTERIA_DR Location: SE

ADA ID: BC9A49AB31F7 Ramp Type: PerpDiag Initial Pass/Fail: Fail Overall Compliance: No Severity Score: 37.5

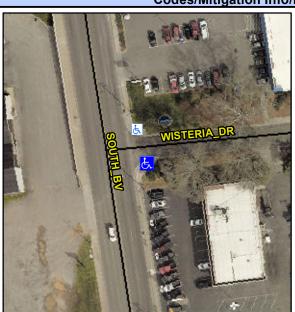
Field Measure	ements/C	unipo	Hent Comphance	
Compliance Description		Data	Compliance Description		Data
N/A	Ramp Length (in)	65.0	No	Ramp Slope (%)	9.2
Yes	Ramp Width (in)	49.0	No	Ramp XSlope (%)	7.6
N/A	Flare Type LT	N/A	N/A	Flare Type RT	N/A
N/A	Flare Slope LT (%)	N/A	N/A	Flare Slope RT (%)	N/A
N/A	Flare Traversable LT?	N/A	N/A	Flare Traversable RT?	N/A
N/A	Landing Length (in)	N/A	N/A	DWS Provided?	N/A
N/A	Landing Width (in)	N/A	N/A	DWS Contrast?	N/A
N/A	Landing Slope (%)	N/A	N/A	DWS Length (in)	N/A
N/A	Landing X Slope (%)	N/A	N/A	DWS Full Width?	N/A
N/A	Landing Curb? (Y/N)	N/A	N/A	DWS Offset (in)	N/A
N/A	Shared Landing?	N/A			
N/A	Gutter Ponding?	N/A	N/A	Gutter Slope (%)	N/A
N/A	Gutter Lip Ht (in)	N/A	N/A	Gutter X Slope (%)	N/A
N/A	Painted X Walk1?	No	N/A	Painted X Walk2?	No
	X Walk 1 Direction	To N		X Walk 2 Direction	To W
N/A	X Walk 1 Width (in)	N/A	N/A	X Walk 2 Width (in)	N/A
	X Walk 1 Slope (%)	6.8		X Walk 2 Slope (%)	9.0

X Walk 1 X Slope (%)	6.3		X Walk 2 X Slope (%)	3.0
N/A	Ramp inside XWalk1?	N/A	N/A	Ramp inside XWalk2?	N/A
	Road Slope (%)	4.2	N/A	Clear Space?	N/A
	Road X Slope (%)	7.5	N/A	Clear Space to XWalk (in)	N/A
N/A	Any Obstructions?	N/A	N/A	Storm Grate/Utility Hazard?	N/A
	Obstruction Type			Storm Grate/Utility Type	
		N/A			N/A
			Yes	Surface Condition? (G/P)	Good

Possible Solution	
Possible Solutions:	9
Remove & Replace Curb Ramp With	ı
Two New Directional Ramps or	•
Equivalent.	ı
	ı
	ı
	ı
Surveyor Notes:	ı
N/A	ı
	ı
	ı
	ı
PROW/ADA:	ı
Not Found, R304.2.2, R304.5.3	ı
	I
