Access Compliance Report

Public Rights-of-Way

(Curb Ramps)

| Intersection ID: 13247 | Main Street: MERRIMAN_AV | Cross Street: W_KINGSTON_AV | Location: SW |

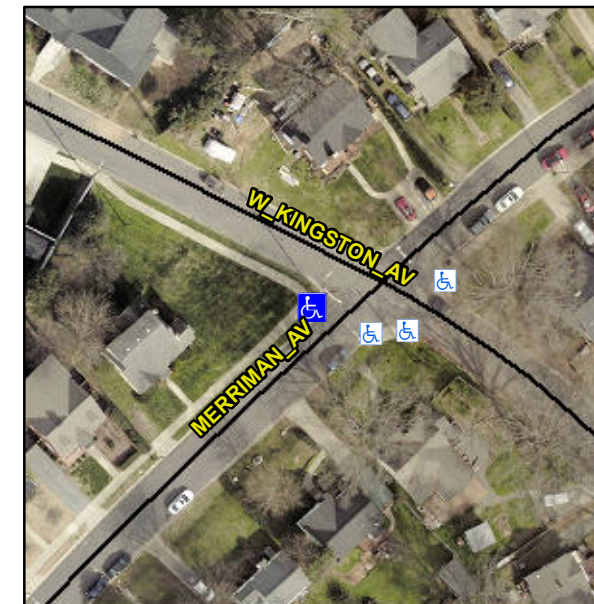
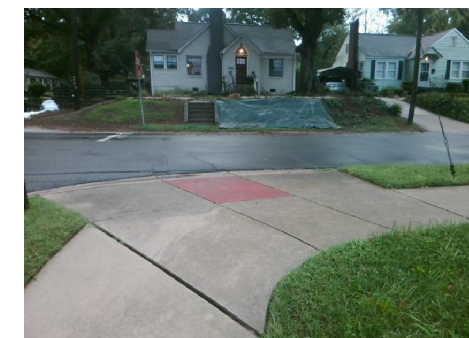
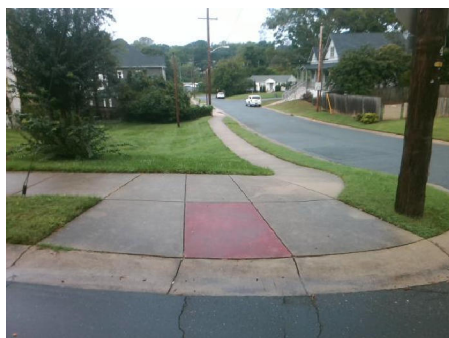
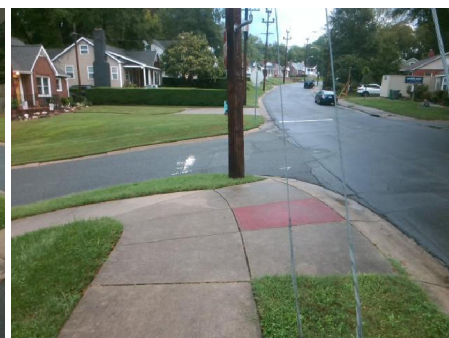
| ADA ID: BC9B10DC8125 | Ramp Type: Para | Initial Pass/Fail: Fail | Overall Compliance: No |
| Severity Score: 50 | | | |

R304.3.2, R304.5.3

| Compliance | Description | Data | Compliance | Description | Data |
|---|---|---|---|---|---|
| N/A | Ramp Slope LT (%) | N/A | No | Ramp Slope RT (%) | 13.4 |
| N/A | Ramp XSlope LT (%) | N/A | No | Ramp XSlope RT (%) | 8.0 |

Remove & Replace Entire Ramp.
