Access Compliance Report

Public Rights-of-Way

(Curb Ramps)

Intersection ID: 20234	Main Street: SHOPTON_RD_WEST	Cross Street: WITHERS_RD	Location:	N
ADA ID: BCB36E9BE34F	Ramp Type: Combination1	Initial Pass/Fail: Fail	Overall Compliance: No	Severity Score: 26.25
Codes/Mitigation Info/Possible Solution		Field Measurements/Component Compliance

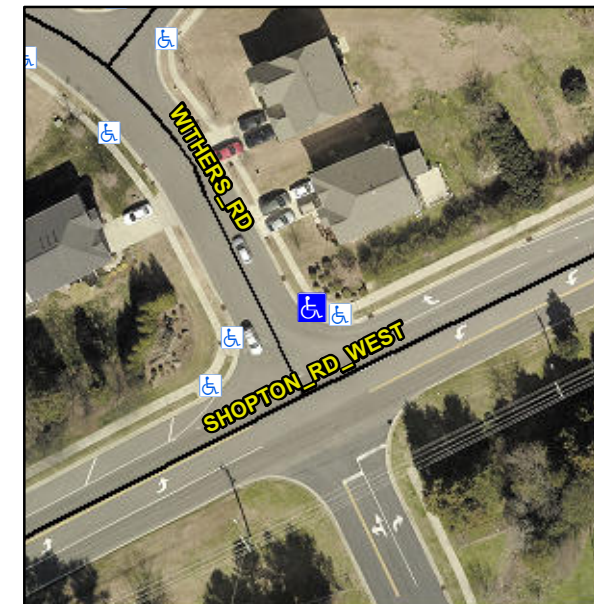
LT RP < 5%

R304.5.3, R304.3.2

Compliance	Description	Data	Compliance	Description	Data
N/A	Ramp Length LT (in)	53.0	N/A	Ramp Length RT (in)	44.0
Yes	Ramp Width LT (in)	48.0	Yes	Ramp Width RT (in)	48.0
Yes	Ramp Slope LT (%)	4.3	No	Ramp Slope RT (%)	18.8
Yes	Ramp XSlope LT (%)	1.9	No	Ramp XSlope RT (%)	2.5
N/A	Ramp Length (in)	49.0	Yes	Ramp Slope (%)	6.2
Yes	Ramp Width (in)	48.0	No	Ramp XSlope (%)	4.0
N/A	Flare Type LT	N/A	N/A	Flare Type RT	N/A
N/A	Flare Slope LT (%)	N/A	N/A	Flare Slope RT (%)	N/A
N/A	Flare Traversable LT?	N/A	N/A	Flare Traversable RT?	N/A
N/A	Landing Length (in)	N/A	N/A	DWS Provided?	N/A
N/A	Landing Width (in)	N/A	N/A	DWS Contrast?	N/A
N/A	Landing Slope (%)	N/A	N/A	DWS Length (in)	N/A
N/A	Landing X Slope (%)	N/A	N/A	DWS Full Width?	N/A
N/A	Landing Curb? (Y/N)	N/A	N/A	DWS Offset (in)	N/A
N/A	Shared Landing?	N/A			
N/A	Gutter Ponding?	N/A	N/A	Gutter Slope (%)	N/A
N/A	Gutter Lip Ht (in)	N/A	N/A	Gutter X Slope (%)	N/A
N/A	Painted X Walk1?	No	N/A	Painted X Walk2?	N/A

Remove & Replace Entire Ramp.

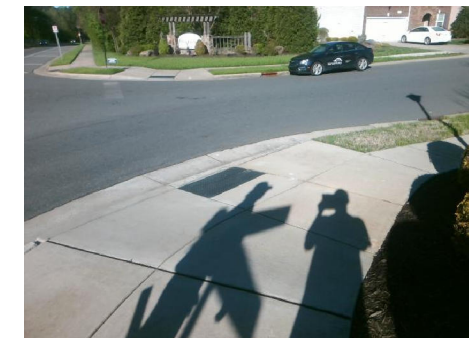
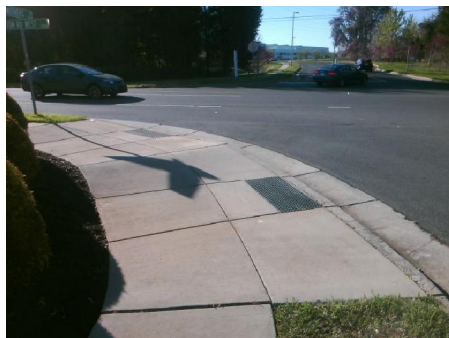
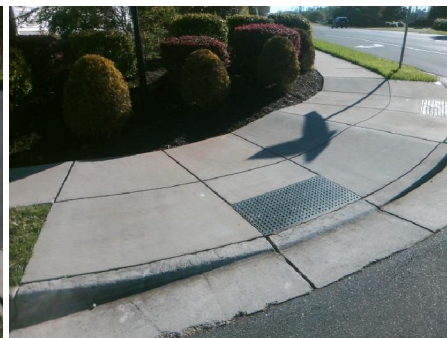
X Walk 1 Direction	To SW		X Walk 2 Direction	N/A
	X Walk 1 Width (in)	N/A		X Walk 2 Width (in)	N/A
	X Walk 1 Slope (%)	1.8		X Walk 2 Slope (%)	N/A
	X Walk 1 X Slope (%)	2.5		X Walk 2 X Slope (%)	N/A
N/A	Ramp inside XWalk1?	N/A	N/A	Ramp inside XWalk2?	N/A
	Road Slope (%)	N/A		Clear Space?	N/A
	Road X Slope (%)	N/A	N/A	Clear Space to XWalk (in)	N/A
			N/A	Any Obstruction?	N/A
				Obstruction Type	N/A
			N/A	Storm Grate/Utility Hazard?	N/A
				Storm Grate/Utility Type	N/A
Yes	Surface Condition? (G/P)	Good			
	Curb Slope (%)	4.3
