## **Access Compliance Report Public Rights-of-Way** (Curb Ramps)

Intersection ID: 22011 Main Street: SOUTH\_BV Cross Street: HILL\_RD Location: SE **Overall Compliance: No** Severity Score: 13.75 ADA ID: BCB645694527 Ramp Type: Para Initial Pass/Fail: Fail

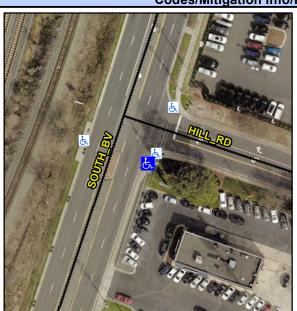
-055ible Solution	
Possible Solutions:	С
Remove & Replace Entire Ramp.	
·	Y
	N
	N
	N
	N
Surveyor Notes:	N
N/A	N
	N
	N
	N
PROW/ADA:	N
R304.3.2, R304.5.3	N
	N

Field Measurements/Component Compliance  Compliance Description Data Compliance Description Data							
N/A	Ramp Length LT (in)	58.0	N/A	Ramp Length RT (in)	58.0		
Yes	Ramp Width LT (in)	60.0	Yes	Ramp Width RT (in)	71.0		
No	Ramp Slope LT (%)	9.3	No	Ramp Slope RT (%)	9.0		
No	Ramp XSlope LT (%)	2.9	No	Ramp XSlope RT (%)	2.1		
N/A	Landing Length (in)	N/A	N/A	DWS Provided?	N/A		
N/A	Landing Width (in)	N/A	N/A	DWS Contrast?	N/A		
N/A	Landing Slope (%)	N/A	N/A	DWS Length (in)	N/A		
N/A	<b>3</b> . ( )	N/A	N/A	DWS Full Width?	N/A		
N/A	Landing X Slope (%)						
	Landing Curb? (Y/N)	N/A	N/A	DWS Offset (in)	N/A		
N/A	Shared Landing?	N/A	NI/A	Otan Olana (0/ )	NI/A		
N/A	Gutter Ponding?	N/A	N/A	Gutter Slope (%)	N/A		
N/A	Gutter Lip Ht (in)	N/A	N/A	Gutter X Slope (%)	N/A		
N/A	Painted X Walk1?	No	N/A	Painted X Walk2?	N/A		
	X Walk 1 Direction	To NW		X Walk 2 Direction	N/A		
N/A	X Walk 1 Width (in)	N/A	N/A	X Walk 2 Width (in)	N/A
