Access Compliance Report

Public Rights-of-Way

(Curb Ramps)

Intersection ID: 12274	Main Street: BERRYHILL_RD	Cross Street: MORTON_ST	Location: SE
ADA ID: BD1A789E2109	Ramp Type: Combination1	Initial Pass/Fail: Fail	Overall Compliance: No
Severity Score: 47.5			
Codes/Mitigation Info/Possible Solution		Field Measurements/Component Compliance

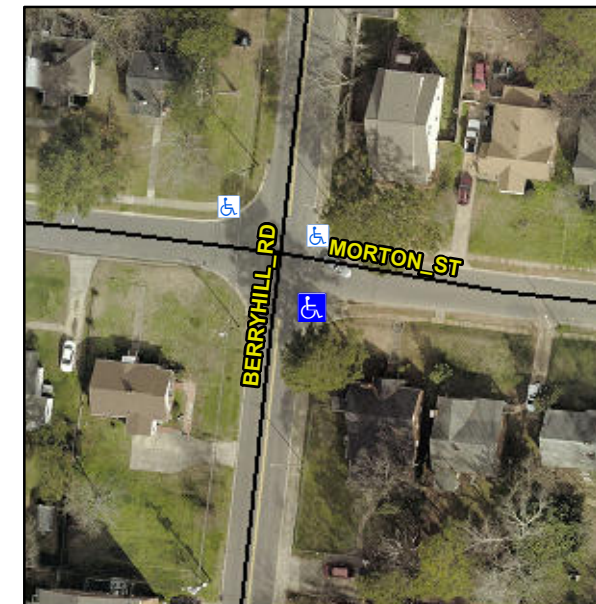
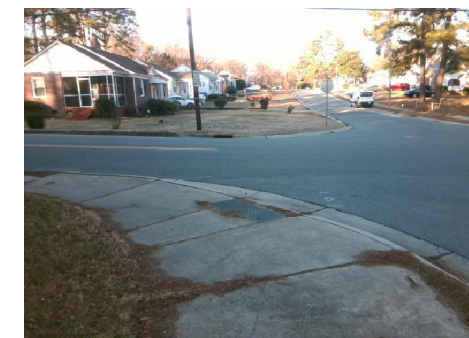
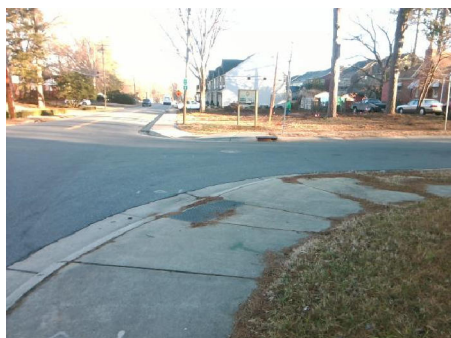
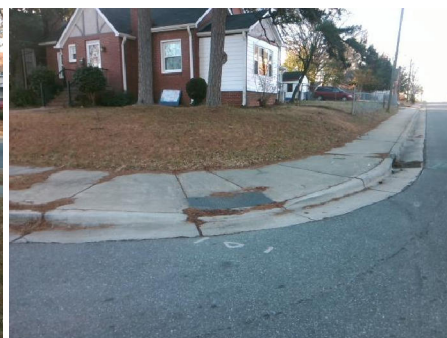
LT RP < 5%

Not Found, R304.5.1, R304.5.1, R304.5.3

Compliance	Description	Data	Compliance	Description	Data
N/A	Ramp Length LT (in)	94.0	N/A	Ramp Length RT (in)	56.5
No	Ramp Width LT (in)	41.0	Yes	Ramp Width RT (in)	96.0
Yes	Ramp Slope LT (%)	2.1	Yes	Ramp Slope RT (%)	7.2
No	Ramp XSlope LT (%)	5.1	No	Ramp XSlope RT (%)	5.6
N/A	Ramp Length (in)	94.0	Yes	Ramp Slope (%)	6.7
No	Ramp Width (in)	26.0	No	Ramp XSlope (%)	2.1
N/A	Flare Type LT	N/A	N/A	Flare Type RT	N/A
N/A	Flare Slope LT (%)	N/A	N/A	Flare Slope RT (%)	N/A
N/A	Flare Traversable LT?	N/A	N/A	Flare Traversable RT?	N/A
N/A	Landing Length (in)	N/A	N/A	DWS Provided?	N/A
N/A	Landing Width (in)	N/A	N/A	DWS Contrast?	N/A
N/A	Landing Slope (%)	N/A	N/A	DWS Length (in)	N/A
N/A	Landing X Slope (%)	N/A	N/A	DWS Full Width?	N/A
N/A	Landing Curb? (Y/N)	N/A	N/A	DWS Offset (in)	N/A
N/A	Shared Landing?	N/A			
N/A	Gutter Ponding?	N/A	N/A	Gutter Slope (%)	N/A
N/A	Gutter Lip Ht (in)	N/A	N/A	Gutter X Slope (%)	N/A
N/A	Painted X Walk1?	No	N/A	Painted X Walk2?	N/A

Remove & Replace Entire Ramp.
