# Access Compliance Report

## Public Rights-of-Way

### (Curb Ramps)

Intersection ID: 5408	Main Street: CARVER_PL	Cross Street: ROCKWELL_BV	Location: N
ADA ID: BD2A170ED88C	Ramp Type: Para	Initial Pass/Fail: Fail	Overall Compliance: No
			Severity Score: 21.25

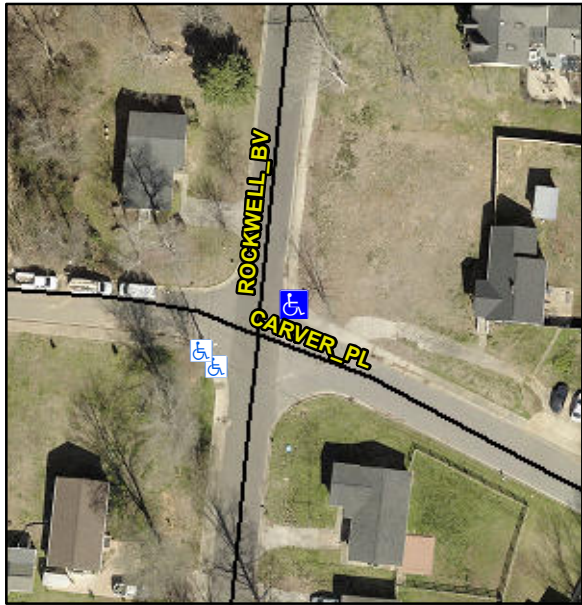
Possible Solutions:		Compliance	Description	Data	Compliance	Description	Data
	Remove & Replace Entire Ramp.		N/A	Ramp Length LT (in)	55.0	N/A	Ramp Length RT (in)	58.0
			No	Ramp Width LT (in)	37.0	No	Ramp Width RT (in)	36.0
			Yes	Ramp Slope LT (%)	7.3	No	Ramp Slope RT (%)	8.4
			Yes	Ramp XSlope LT (%)	1.4	Yes	Ramp XSlope RT (%)	0.1
			N/A	Landing Length (in)	N/A	N/A	DWS Provided?	N/A
			N/A	Landing Width (in)	N/A	N/A	DWS Contrast?	N/A
			N/A	Landing Slope (%)	N/A	N/A	DWS Length (in)	N/A
			N/A	Landing X Slope (%)	N/A	N/A	DWS Full Width?	N/A
			N/A	Landing Curb? (Y/N)	N/A	N/A	DWS Offset (in)	N/A
Surveyor Notes:			N/A	Shared Landing?	N/A			
PROW/ADA:			N/A	Gutter Ponding?	N/A	N/A	Gutter Slope (%)	N/A
			N/A	Gutter Lip Ht (in)	N/A	N/A	Gutter X Slope (%)	N/A
			N/A	Painted X Walk1?	No	N/A	Painted X Walk2?	N/A
				X Walk 1 Direction	To SW		X Walk 2 Direction	N/A

N/A	X Walk 1 Width (in)	N/A	N/A	X Walk 2 Width (in)	N/A
				X Walk 1 Slope (%)	1.2		X Walk 2 Slope (%)	N/A
				X Walk 1 X Slope (%)	0.1		X Walk 2 X Slope (%)	N/A
			N/A	Ramp inside XWalk1?	N/A	N/A	Ramp inside XWalk2?	N/A
				Road Slope (%)	N/A	N/A	Clear Space?	N/A
				Road X Slope (%)	N/A	N/A	Clear Space to XWalk (in)	N/A
			N/A	Any Obstructions?	N/A	N/A	Storm Grate/Utility Hazard?	N/A
				Obstruction Type			Storm Grate/Utility Type	
Total Cost:					N/A			N/A
						Yes	Surface Condition? (G/P)	Good
						N/A	Curb Slope (%)	16.1
