## Access Compliance Report Public Rights-of-Way (Curb Ramps)

Intersection ID: N/A Main Street: N\_TRYON\_ST Cross Street: HAMPTON\_CHURCH\_RD Location: SE

ADA ID: BD54E8FD5746 Ramp Type: PerpDiag Initial Pass/Fail: Fail Overall Compliance: No Severity Score: 33.75

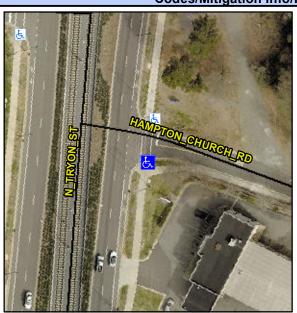
R304.5.1, R304.2.2, R304.5.3

| Compliance Description | | Data | Comp | liance Description | Data |
|---|---|---|---|---|---|
| N/A | Ramp Length (in) | 88.0 | No | Ramp Slope (%) | 9.1 |
| No | Ramp Width (in) | 46.5 | No | Ramp XSlope (%) | 5.6 |

Remove & Replace Curb Ramp With Two New Directional Ramps or Equivalent.
