Access Compliance Report

Public Rights-of-Way

(Curb Ramps)

Intersection ID: 48259	Main Street: BELMONT_RUN_LN	Cross Street: BACK_CREEK_CHURCH_RD	Location: SW
ADA ID: BDA1BE45B093	Ramp Type: Perp	Initial Pass/Fail: Pass	Overall Compliance: No
		Severity Score: 12.5

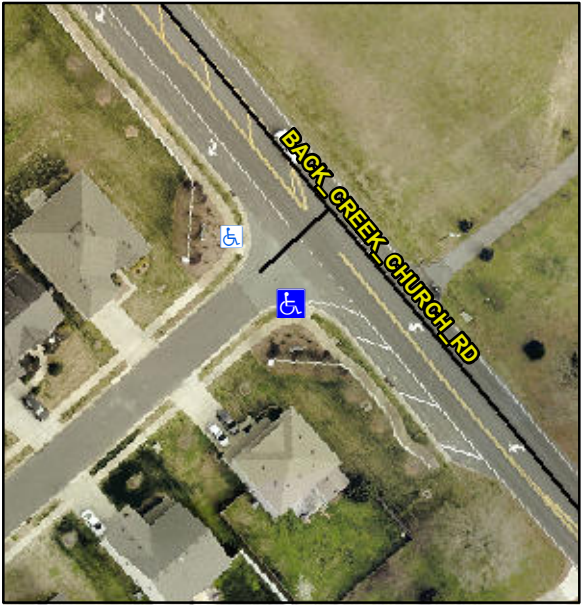
Possible Solutions:		Compliance	Description	Data	Compliance
	Remove & Replace Entire Ramp.		N/A	Ramp Length (in)	46.5	Yes
	Remove & Replace Gutter.		Yes	Ramp Width (in)	48.0	Yes
			N/A	Flare Type LT	Sloped	N/A
			N/A	Flare Slope LT (%)	6.8	N/A
			N/A	Flare Traversable LT?	No	N/A
			Yes	Landing Length (in)	60.0	Yes
			Yes	Landing Width (in)	48.0	Yes
			Yes	Landing Slope (%)	0.8	Yes
			Yes	Landing X Slope (%)	1.8	Yes
<p>Surveyor Notes:</p> <p>N/A</p> <p>PROW/ADA:</p> <p>Not Found, R305.2, R302.7.2, R304.5.4, R304.5.3</p>			N/A	Flare Type RT	N/A	N/A
			N/A	Flare Slope RT (%)	8.7	N/A
			N/A	Flare Traversable RT?	No	N/A
			Yes	DWS Provided?	Yes	Yes
			Yes	DWS Contrast?	Yes	Yes
			Yes	DWS Length (in)	24.5	Yes
			Yes	DWS Full Width?	Yes	Yes
			N/A	DWS Offset (in)	2.5	N/A
			N/A	Gutter Slope (%)	5.7	N/A
			No	Gutter X Slope (%)	2.1	N/A

<p>Total Cost: \$ 2600.00</p>			N/A	Painted X Walk1?	No	N/A
				X Walk 1 Direction	To NW	N/A
			N/A	X Walk 1 Width (in)	N/A	N/A
				X Walk 1 Slope (%)	1.0	N/A
				X Walk 1 X Slope (%)	2.4	N/A
			N/A	Ramp inside XWalk1?	N/A	N/A
			N/A	Ramp inside XWalk2?	N/A	N/A
			N/A	Clear Space?	Yes	N/A
			N/A	Clear Space to XWalk (in)	N/A	N/A
			Yes	Storm Grate/Utility Hazard?	No	Yes
<p>Obstruction Type</p>				Storm Grate/Utility Type		N/A
			N/A	Surface Condition? (G/P)	Good	Yes
