Access Compliance Report

Public Rights-of-Way

(Curb Ramps)

Intersection ID: 31765	Main Street: FIRST_RUN_CT	Cross Street: PINYON_PINE_LN	Location: W
ADA ID: BDC0DE3D94CE	Ramp Type: Combination2	Initial Pass/Fail: Fail	Overall Compliance: No
			Severity Score: 21.25

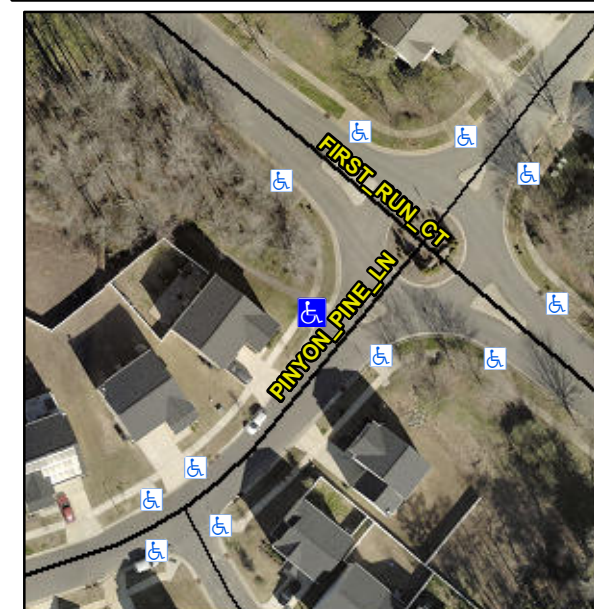
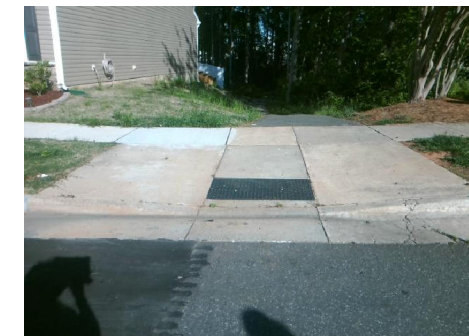
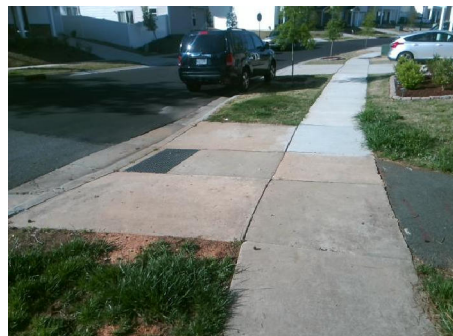
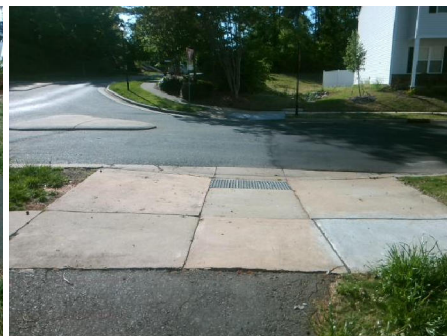
LT RP < 5%

R304.5.1, R304.5.3

Compliance	Description	Data	Compliance	Description	Data
N/A	Ramp Length LT (in)	69.0	N/A	Ramp Length RT (in)	60.5
N/A	Ramp Width LT (in)	48.0	Yes	Ramp Width RT (in)	48.0
N/A	Ramp Slope LT (%)	1.5	Yes	Ramp Slope RT (%)	6.4
N/A	Ramp XSlope LT (%)	4.6	No	Ramp XSlope RT (%)	3.0
N/A	Ramp Length (in)	85.0	Yes	Ramp Slope (%)	6.0
No	Ramp Width (in)	47.0	No	Ramp XSlope (%)	5.6
N/A	Flare Type LT	N/A	N/A	Flare Type RT	N/A
N/A	Flare Slope LT (%)	N/A	N/A	Flare Slope RT (%)	N/A
N/A	Flare Traversable LT?	N/A	N/A	Flare Traversable RT?	N/A
N/A	Landing Length (in)	N/A	N/A	DWS Provided?	N/A
N/A	Landing Width (in)	N/A	N/A	DWS Contrast?	N/A
N/A	Landing Slope (%)	N/A	N/A	DWS Length (in)	N/A
N/A	Landing X Slope (%)	N/A	N/A	DWS Full Width?	N/A
N/A	Landing Curb? (Y/N)	N/A	N/A	DWS Offset (in)	N/A
N/A	Shared Landing?	N/A			
N/A	Gutter Ponding?	N/A	N/A	Gutter Slope (%)	N/A
N/A	Gutter Lip Ht (in)	N/A	N/A	Gutter X Slope (%)	N/A
N/A	Painted X Walk1?	No	N/A	Painted X Walk2?	N/A

Remove & Replace Entire Ramp.
