# Access Compliance Report

## Public Rights-of-Way

### (Curb Ramps)

Intersection ID: 3821	Main Street: BERSHIRE_LN	Cross Street: MARBLE_HILL_DR	Location: NW
ADA ID: BDE20092699F	Ramp Type: Perp	Initial Pass/Fail: Fail	Overall Compliance: No
Severity Score: 25			
Codes/Mitigation Info/Possible Solution		Field Measurements/Component Compliance

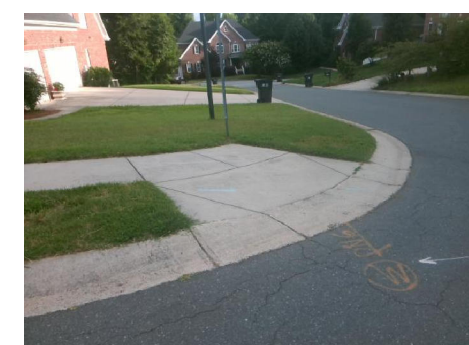
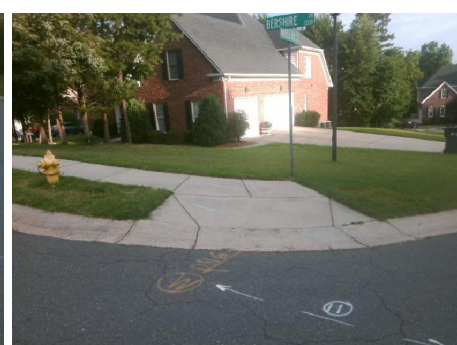
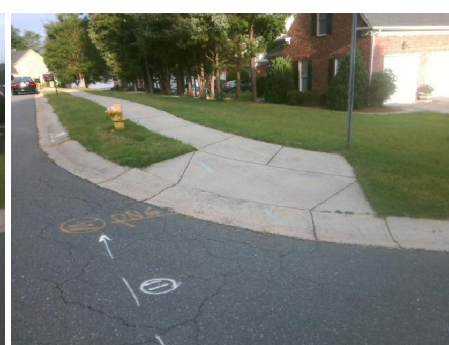
**Not Found, R304.5.3**

Compliance	Description	Data	Compliance	Description	Data
N/A	Ramp Length (in)	49.0	Yes	Ramp Slope (%)	5.6
Yes	Ramp Width (in)	69.0	No	Ramp XSlope (%)	11.1
N/A	Flare Type LT	N/A	N/A	Flare Type RT	N/A
N/A	Flare Slope LT (%)	N/A	N/A	Flare Slope RT (%)	N/A
N/A	Flare Traversable LT?	N/A	N/A	Flare Traversable RT?	N/A
N/A	Landing Length (in)	N/A	N/A	DWS Provided?	N/A
N/A	Landing Width (in)	N/A	N/A	DWS Contrast?	N/A
N/A	Landing Slope (%)	N/A	N/A	DWS Length (in)	N/A
N/A	Landing X Slope (%)	N/A	N/A	DWS Full Width?	N/A
N/A	Landing Curb? (Y/N)	N/A	N/A	DWS Offset (in)	N/A
N/A	Shared Landing?	N/A			
N/A	Gutter Ponding?	N/A	N/A	Gutter Slope (%)	N/A
N/A	Gutter Lip Ht (in)	N/A	N/A	Gutter X Slope (%)	N/A
N/A	Painted X Walk1?	No	N/A	Painted X Walk2?	N/A
	X Walk 1 Direction	To S		X Walk 2 Direction	N/A
N/A	X Walk 1 Width (in)	N/A	N/A	X Walk 2 Width (in)	N/A
	X Walk 1 Slope (%)	9.6		X Walk 2 Slope (%)	N/A
	X Walk 1 X Slope (%)	3.0		X Walk 2 X Slope (%)	N/A

**Remove & Replace Entire Ramp.**
