## Access Compliance Report Public Rights-of-Way (Curb Ramps)

Intersection ID: 49125 Main Street: LEGOLAS\_LN Cross Street: LAVETA\_RD Location: NE

ADA ID: BE0B344B3246 Ramp Type: PerpDiag Initial Pass/Fail: Fail Overall Compliance: No Severity Score: 13.75

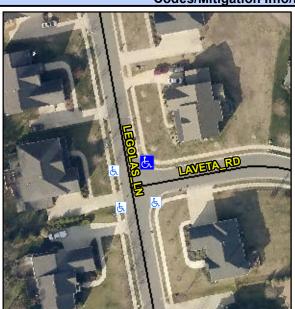
Not Found, R304.2.2, R304.5.3

Compliance Description		Data	Compliance Description		Data
N/A	Ramp Length (in)	47.0	No	Ramp Slope (%)	10.9
Yes	Ramp Width (in)	48.0	No	Ramp XSlope (%)	2.2
N/A	Flare Type LT	N/A	N/A	Flare Type RT	N/A
N/A	Flare Slope LT (%)	N/A	N/A	Flare Slope RT (%)	N/A
N/A	Flare Traversable LT?	N/A	N/A	Flare Traversable RT?	N/A
N/A	Landing Length (in)	N/A	N/A	DWS Provided?	N/A
N/A	Landing Width (in)	N/A	N/A	DWS Contrast?	N/A
N/A	Landing Slope (%)	N/A	N/A	DWS Length (in)	N/A
N/A	Landing X Slope (%)	N/A	N/A	DWS Full Width?	N/A
N/A	Landing Curb? (Y/N)	N/A	N/A	DWS Offset (in)	N/A
N/A	Shared Landing?	N/A			
N/A	Gutter Ponding?	N/A	N/A	Gutter Slope (%)	N/A
N/A	Gutter Lip Ht (in)	N/A	N/A	Gutter X Slope (%)	N/A
N/A	Painted X Walk1?	No	N/A	Painted X Walk2?	No
	X Walk 1 Direction	To W		X Walk 2 Direction	To S
N/A	X Walk 1 Width (in)	N/A	N/A	X Walk 2 Width (in)	N/A
	X Walk 1 Slope (%)	2.0		X Walk 2 Slope (%)	2.0
	X Walk 1 X Slope (%)	1.8		X Walk 2 X Slope (%)	0.8

N/A	Ramp inside XWalk1?	N/A	N/A	Ramp inside XWalk2?	N/A
	Road Slope (%)	2.7	N/A	Clear Space?	N/A
	Road X Slope (%)	0.1	N/A	Clear Space to XWalk (in)	N/A
N/A	Any Obstructions?	N/A	N/A	Storm Grate/Utility Hazard?	N/A
	Obstruction Type		l	Storm Grate/Utility Type	
		N/A			N/A
			Yes	Surface Condition? (G/P)	Good

Remove & Replace Curb Ramp With Two New Directional Ramps or Equivalent.
