# Access Compliance Report

## Public Rights-of-Way

| Intersection ID: 28929 | Main Street: WADE ARDREY RD | Cross Street: CAMPBELL HALL CT | Location: SE |
| ADA ID: BE124B8778E1 | Ramp Type: Perp | Initial Pass/Fail: Fail | Overall Compliance: No |

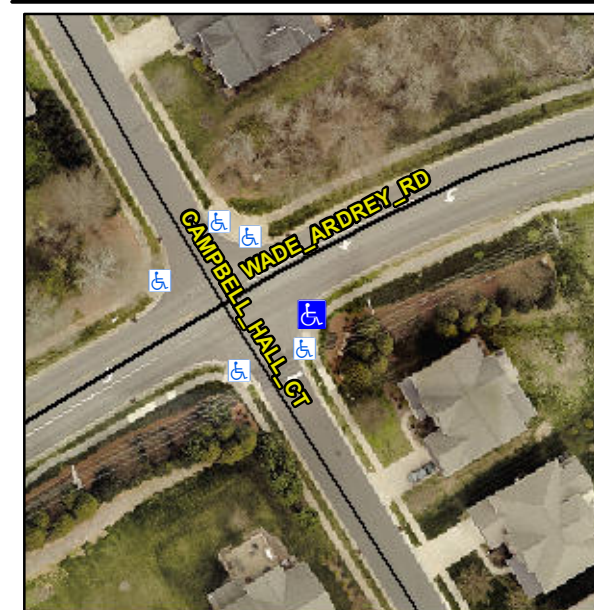
**Not Found, R304.2.2**

| Compliance | Description | Data | Compliance | Description | Data |
|---|---|---|---|---|---|
| N/A | Ramp Length (in) | 48.0 | No | Ramp Slope (%) | 8.6 |

**Remove & Replace Entire Ramp.**
