Access Compliance Report

Public Rights-of-Way

(Curb Ramps)

Intersection ID: 53962	Main Street: LILAC_TREE_AV	Cross Street: DENBUR_DR	Location: S
ADA ID: BE9FF8B6D256	Ramp Type: Perp	Initial Pass/Fail: Fail	Overall Compliance: No
Severity Score: 10			
Codes/Mitigation Info/Possible Solution		Field Measurements/Component Compliance

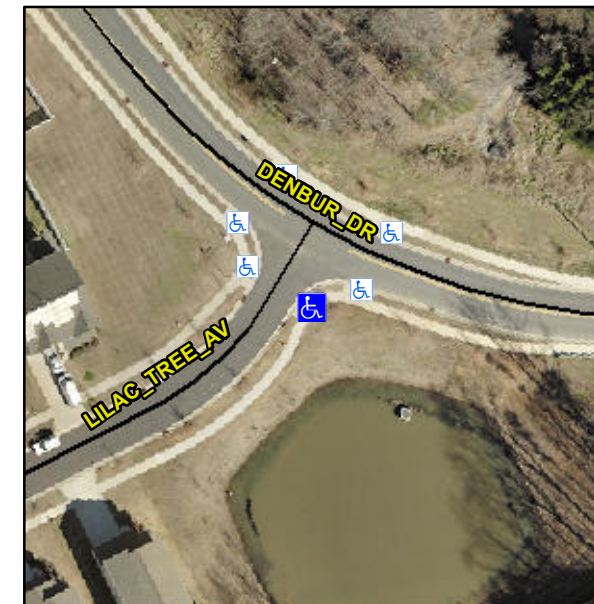
Not Found, R304.5.1, R304.5.3

Compliance	Description	Data	Compliance	Description	Data
N/A	Ramp Length (in)	48.0	Yes	Ramp Slope (%)	5.1
No	Ramp Width (in)	47.5	No	Ramp XSlope (%)	5.0
N/A	Flare Type LT	N/A	N/A	Flare Type RT	N/A
N/A	Flare Slope LT (%)	N/A	N/A	Flare Slope RT (%)	N/A
N/A	Flare Traversable LT?	N/A	N/A	Flare Traversable RT?	N/A
N/A	Landing Length (in)	N/A	N/A	DWS Provided?	N/A
N/A	Landing Width (in)	N/A	N/A	DWS Contrast?	N/A
N/A	Landing Slope (%)	N/A	N/A	DWS Length (in)	N/A
N/A	Landing X Slope (%)	N/A	N/A	DWS Full Width?	N/A
N/A	Landing Curb? (Y/N)	N/A	N/A	DWS Offset (in)	N/A
N/A	Shared Landing?	N/A			
N/A	Gutter Ponding?	N/A	N/A	Gutter Slope (%)	N/A
N/A	Gutter Lip Ht (in)	1.5	N/A	Gutter X Slope (%)	N/A
N/A	Painted X Walk1?	No	N/A	Painted X Walk2?	N/A
	X Walk 1 Direction	To NW		X Walk 2 Direction	N/A
N/A	X Walk 1 Width (in)	N/A	N/A	X Walk 2 Width (in)	N/A
	X Walk 1 Slope (%)	1.9		X Walk 2 Slope (%)	N/A
	X Walk 1 X Slope (%)	5.6		X Walk 2 X Slope (%)	N/A

Remove & Replace Entire Ramp.
