Access Compliance Report Public Rights-of-Way (Curb Ramps)

Intersection ID: 50240 Main Street: LONGSTONE_LN Cross Street: CEDAR_WALK_LN Location: E

ADA ID: BF4AF32FBBED Ramp Type: BlendTrans1 Initial Pass/Fail: Fail Overall Compliance: No Severity Score: 12.5

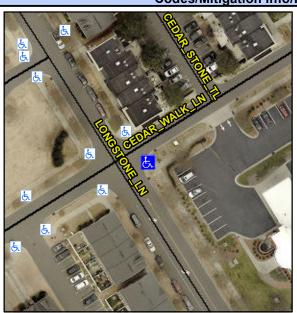
Not Found, R304.5.3

Fleid Measurements/Component Compliance					
Compliance Description		Data	Compliance Description		Data
N/A	Ramp Length (in)	96.0	Yes	BlendTrans Slope (%)	4.5
Yes	Ramp Width (in)	48.0	No	BlendTrans XSlope (%)	6.2
N/A	Flare Type LT	N/A	N/A	Flare Type RT	N/A
N/A	Flare Slope LT (%)	N/A	N/A	Flare Slope RT (%)	N/A
N/A	Flare Traversable LT?	N/A	N/A	Flare Traversable RT?	N/A
N/A	Landing Length (in)	N/A	N/A	DWS Provided?	N/A
N/A	Landing Width (in)	N/A	N/A	DWS Contrast?	N/A
N/A	Landing Slope (%)	N/A	N/A	DWS Length (in)	N/A
N/A	Landing X Slope (%)	N/A	N/A	DWS Full Width?	N/A
N/A	Landing Curb? (Y/N)	N/A	N/A	DWS Offset (in)	N/A
N/A	Shared Landing?	N/A			
N/A	Gutter Ponding?	N/A	N/A	Gutter Slope (%)	N/A
N/A	Gutter Lip Ht (in)	N/A	N/A	Gutter X Slope (%)	N/A
N/A	Painted X Walk1?	No	N/A	Painted X Walk2?	No
	X Walk 1 Direction	To NW		X Walk 2 Direction	To SW
	X Walk 1 Width (in)	N/A		X Walk 2 Width (in)	N/A
	X Walk 1 Slope (%)	2.8		X Walk 2 Slope (%)	2.5

Remove & Replace Curb Ramp With
Two New Directional Ramps or
Equivalent.
