# Access Compliance Report

## Public Rights-of-Way

### (Curb Ramps)

Intersection ID: 26390	Main Street: BAYBROOK_LN	Cross Street: BEVINGTON_PL	Location: NW
ADA ID: BF67D9EF414C	Ramp Type: PerpDiag	Initial Pass/Fail: Fail	Overall Compliance: No
		Severity Score: 12.5

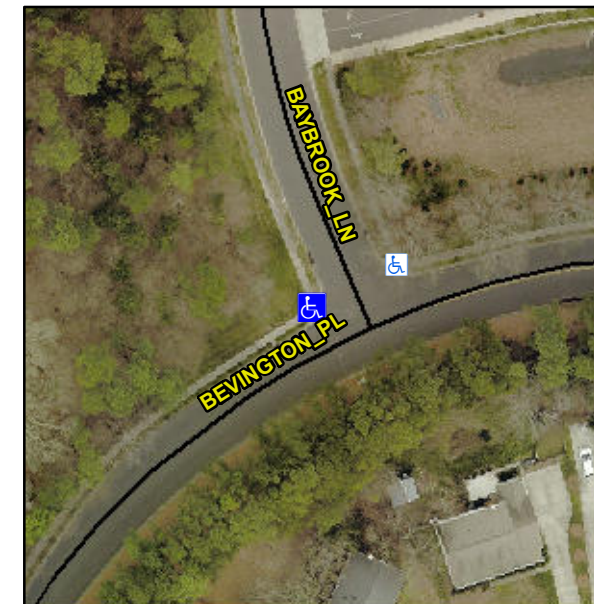
Compliance	Description	Data	Compliance	Description	Data
N/A	Ramp Length (in)	79.0	No	Ramp Slope (%)	8.6
Yes	Ramp Width (in)	48.0	Yes	Ramp XSlope (%)	0.4
N/A	Flare Type LT	N/A	N/A	Flare Type RT	N/A
N/A	Flare Slope LT (%)	N/A	N/A	Flare Slope RT (%)	N/A
N/A	Flare Traversable LT?	N/A	N/A	Flare Traversable RT?	N/A
N/A	Landing Length (in)	N/A	N/A	DWS Provided?	N/A
N/A	Landing Width (in)	N/A	N/A	DWS Contrast?	N/A
N/A	Landing Slope (%)	N/A	N/A	DWS Length (in)	N/A
N/A	Landing X Slope (%)	N/A	N/A	DWS Full Width?	N/A
N/A	Landing Curb? (Y/N)	N/A	N/A	DWS Offset (in)	N/A
N/A	Shared Landing?	N/A			
N/A	Gutter Ponding?	N/A	N/A	Gutter Slope (%)	N/A
N/A	Gutter Lip Ht (in)	N/A	N/A	Gutter X Slope (%)	N/A
N/A	Painted X Walk1?	No	N/A	Painted X Walk2?	No
	X Walk 1 Direction	To SE		X Walk 2 Direction	To NE
N/A	X Walk 1 Width (in)	N/A	N/A	X Walk 2 Width (in)	N/A
	X Walk 1 Slope (%)	3.4		X Walk 2 Slope (%)	1.5
	X Walk 1 X Slope (%)	1.6		X Walk 2 X Slope (%)	0.3

N/A	Ramp inside XWalk1?	N/A	N/A	Ramp inside XWalk2?	N/A
	Road Slope (%)	2.5	N/A	Clear Space?	N/A
	Road X Slope (%)	4.1	N/A	Clear Space to XWalk (in)	N/A
N/A	Any Obstructions?	N/A	N/A	Storm Grate/Utility Hazard?	N/A
	Obstruction Type			Storm Grate/Utility Type	
		N/A			N/A
			Yes	Surface Condition? (G/P)	Good

**Remove & Replace Curb Ramp With Two New Directional Ramps or Equivalent.**
