Access Compliance Report Public Rights-of-Way (Curb Ramps)

Intersection ID: 10714Main Street:MULBERRY_CHURCH_RDCross Street:S_I-85_EXIT_33_RALocation:N/AADA ID: BFA38C54A34DRamp Type:PerpInitial Pass/Fail:FailOverall Compliance:NoSeverity Score:12.5

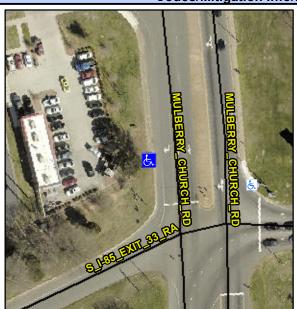
Field Measurements/Component Compliance						
Comp	liance Description	Data	Comp	liance Description	Data	
N/A	Ramp Length (in)	60.5	No	Ramp Slope (%)	9.5	
Yes	Ramp Width (in)	57.0	Yes	Ramp XSlope (%)	0.5	
N/A	Flare Type LT	N/A	N/A	Flare Type RT	N/A	
N/A	Flare Slope LT (%)	N/A	N/A	Flare Slope RT (%)	N/A	
N/A	Flare Traversable LT?	N/A	N/A	Flare Traversable RT?	N/A	
N/A	Landing Length (in)	N/A	N/A	DWS Provided?	N/A	
N/A	Landing Width (in)	N/A	N/A	DWS Contrast?	N/A	
N/A	Landing Slope (%)	N/A	N/A	DWS Length (in)	N/A	
N/A	Landing X Slope (%)	N/A	N/A	DWS Full Width?	N/A	
N/A	Landing Curb? (Y/N)	N/A	N/A	DWS Offset (in)	N/A	
N/A	Shared Landing?	N/A				
N/A	Gutter Ponding?	N/A	N/A	Gutter Slope (%)	N/A	
N/A	Gutter Lip Ht (in)	N/A	N/A	Gutter X Slope (%)	N/A	
N/A	Painted X Walk1?	No	N/A	Painted X Walk2?	N/A	
	X Walk 1 Direction	То Е		X Walk 2 Direction	N/A	
N/A	X Walk 1 Width (in)	N/A	N/A	X Walk 2 Width (in)	N/A	
	X Walk 1 Slope (%)	1.6		X Walk 2 Slope (%)	N/A

Possible Solutions:	9		
Remove & Replace Entire Ramp.			
·	Υ		
	N		
	N		
	N		
	N		
Surveyor Notes:	N		
N/A	N		
	N		
	N		
	N		
PROW/ADA:	N		
Not Found, R304.2.2	N		
	N		
	N
