Access Compliance Report

Public Rights-of-Way (Curb Ramps)

Intersection ID: 48516	Main Street: GALLERIA CLUB LN	Cross Street: GALLERIA BV	Location: SE
ADA ID: C010D68CD9CB	Ramp Type: PerpDiag	Initial Pass/Fail: Fail	Overall Compliance: No
Severity Score: 8.75			
Codes/Mitigation Info/Possible Solution		Field Measurements/Component Compliance

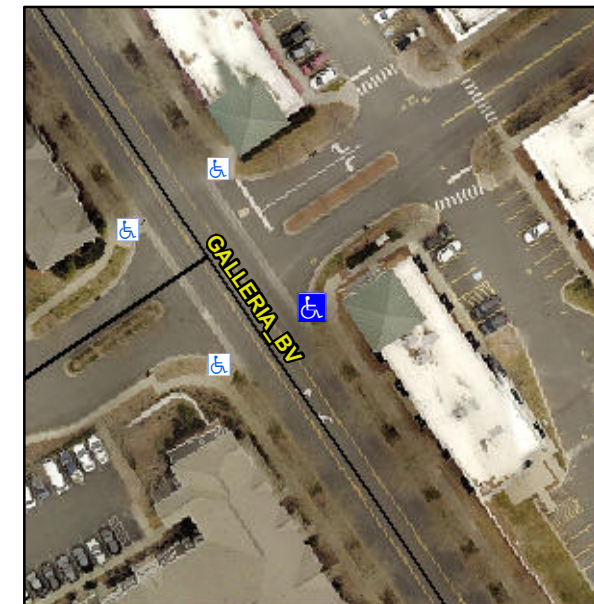
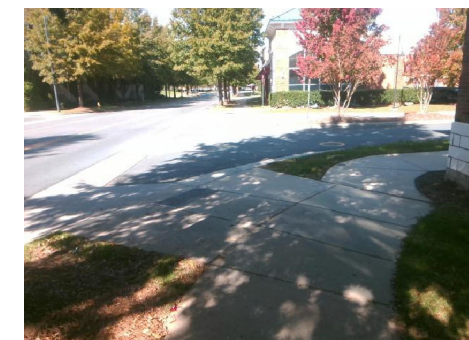
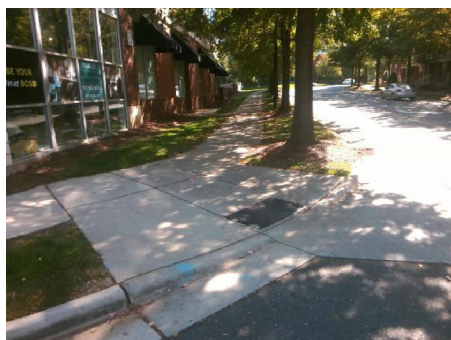
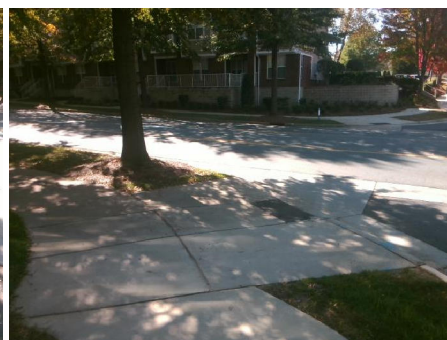
R304.5.1

Compliance	Description	Data	Compliance	Description	Data
N/A	Ramp Length (in)	94.0	Yes	Ramp Slope (%)	6.2
No	Ramp Width (in)	44.0	Yes	Ramp XSlope (%)	1.3
N/A	Flare Type LT	N/A	N/A	Flare Type RT	N/A
N/A	Flare Slope LT (%)	N/A	N/A	Flare Slope RT (%)	N/A
N/A	Flare Traversable LT?	N/A	N/A	Flare Traversable RT?	N/A
N/A	Landing Length (in)	N/A	N/A	DWS Provided?	N/A
N/A	Landing Width (in)	N/A	N/A	DWS Contrast?	N/A
N/A	Landing Slope (%)	N/A	N/A	DWS Length (in)	N/A
N/A	Landing X Slope (%)	N/A	N/A	DWS Full Width?	N/A
N/A	Landing Curb? (Y/N)	N/A	N/A	DWS Offset (in)	N/A
N/A	Shared Landing?	N/A			
N/A	Gutter Ponding?	N/A	N/A	Gutter Slope (%)	N/A
N/A	Gutter Lip Ht (in)	N/A	N/A	Gutter X Slope (%)	N/A
N/A	Painted X Walk1?	No	N/A	Painted X Walk2?	No
	X Walk 1 Direction	To NW		X Walk 2 Direction	To SW
N/A	X Walk 1 Width (in)	N/A	N/A	X Walk 2 Width (in)	N/A
	X Walk 1 Slope (%)	1.4		X Walk 2 Slope (%)	3.4
	X Walk 1 X Slope (%)	2.9		X Walk 2 X Slope (%)	0.8

N/A	Ramp inside XWalk1?	N/A	N/A	Ramp inside XWalk2?	N/A
	Road Slope (%)	1.2	N/A	Clear Space?	N/A
	Road X Slope (%)	3.1	N/A	Clear Space to XWalk (in)	N/A
N/A	Any Obstructions?	N/A	N/A	Storm Grate/Utility Hazard?	N/A
	Obstruction Type			Storm Grate/Utility Type	
		N/A			N/A
			Yes	Surface Condition? (G/P)	Good

Remove & Replace Curb Ramp With Two New Directional Ramps or Equivalent.
