Access Compliance Report Public Rights-of-Way (Curb Ramps)

Intersection ID: 10004304 Main Street: MULLAN_LN Cross Street: REALTA_DR Location: SE ADA ID: C089BC50A90A Ramp Type: BlendTrans1 Initial Pass/Fail: Fail **Overall Compliance: No Severity Score:** 10

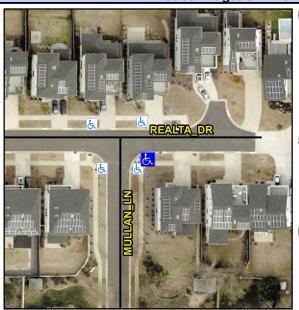
Possible Solution	
Possible Solutions:	<u>c</u>
Remove & Replace Curb Ramp With	N
Two New Directional Ramps or	N
Equivalent.	N
	N
	N
	N
Surveyor Notes:	N
CURB LIP 1.0	N
	N
	N
	N
PROW/ADA:	N
Not Found, R304.5.1	N
	N

Field Measurements/Component Compliance							
Compliance Description Dat			Comp	liance Description	Data		
N/A	Ramp Length (in)	95.5	Yes	BlendTrans Slope (%)	4.0		
No	Ramp Width (in)	47.0	Yes	BlendTrans XSlope (%)	2.6		
N/A	Flare Type LT	N/A	N/A	Flare Type RT	N/A		
N/A	Flare Slope LT (%)	N/A	N/A	Flare Slope RT (%)	N/A		
N/A	Flare Traversable LT?	N/A	N/A	Flare Traversable RT?	N/A		
N/A	Landing Length (in)	N/A	N/A	DWS Provided?	N/A		
N/A	Landing Width (in)	N/A	N/A	DWS Contrast?	N/A		
N/A	Landing Slope (%)	N/A	N/A	DWS Length (in)	N/A		
N/A	Landing X Slope (%)	N/A	N/A	DWS Full Width?	N/A		
N/A	Landing Curb? (Y/N)	N/A	N/A	DWS Offset (in)	N/A		
N/A	Shared Landing?	N/A					
N/A	Gutter Ponding?	N/A	N/A	Gutter Slope (%)	N/A		
N/A	Gutter Lip Ht (in)	N/A	N/A	Gutter X Slope (%)	N/A		
N/A	Painted X Walk1?	No	N/A	Painted X Walk2?	N/A		
	X Walk 1 Direction	To N		X Walk 2 Direction	N/A		
	X Walk 1 Width (in)	N/A		X Walk 2 Width (in)	N/A

X Walk 1 Slope (%)	3.2		X Walk 2 Slope (%)	N/A		
	X Walk 1 X Slope (%)	5.2		X Walk 2 X Slope (%)	N/A		
N/A	Ramp inside XWalk1?	N/A	N/A	Ramp inside XWalk2?	N/A		
	Road Slope (%)	5.2		Clear Space?	N/A		
	Road X Slope (%)	3.2	N/A	Clear Space to XWalk (in)	N/A		
N/A	Any Obstructions?	N/A	N/A	Storm Grate/Utility Hazard?	N/A		
	Obstruction Type			Storm Grate/Utility Type			
		N/A			N/A		
			Yes	Surface Condition? (G/P)	Good		
			No	Curb Slope (%)	5.1
