Access Compliance Report Public Rights-of-Way (Curb Ramps)

Intersection ID: 14111 Main Street: CENTRAL_AV Cross Street: LANSDALE_DR Location: NW

ADA ID: C1E21D6A919E Ramp Type: Combination1 Initial Pass/Fail: Fail Overall Compliance: No Severity Score: 61.25

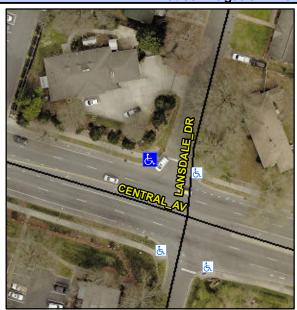
RP < 5%

Not Found, R304.5.1, R304.5.3, R304.3.2

Remove & Replace Entire Ramp.
