Access Compliance Report

Public Rights-of-Way

| Intersection ID: 13722 | Main Street: BASCOM_ST | Cross Street: COMMONWEALTH_AV | Location: W |
| ADA ID: C25D98C57289 | Ramp Type: Directional1 | Initial Pass/Fail: Fail | Overall Compliance: No |

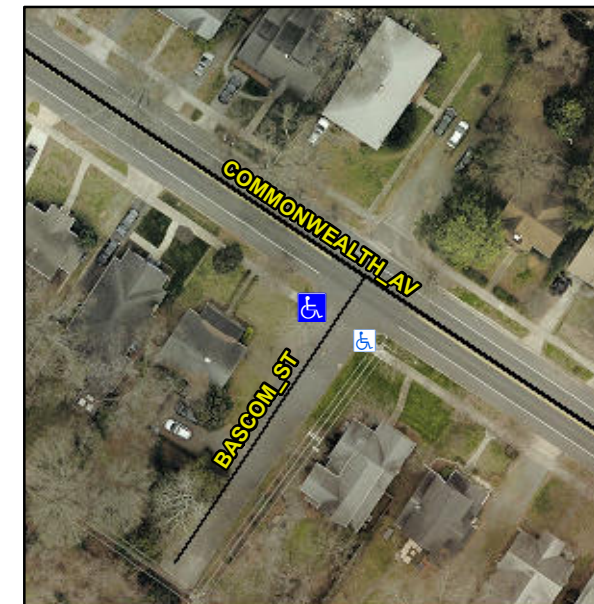
| Severity Score: 8.75 | | | |

R304.5.1

| Compliance | Description | Data | Compliance | Description | Data |
|---|---|---|---|---|---|
| No | Ramp Width (in) | 45.0 | N/A | Grade Break Slope (%) | 0.0 |

Remove & Replace Entire Ramp.
