Access Compliance Report

Public Rights-of-Way

(Curb Ramps)

Intersection ID: N/A	Main Street: SCOFIELD_RD	Cross Street: WINTERCREST_LN	Location: SW
ADA ID: C27A8BA6E5C3	Ramp Type: Combination2	Initial Pass/Fail: Fail	Overall Compliance: No
			Severity Score: 13.75

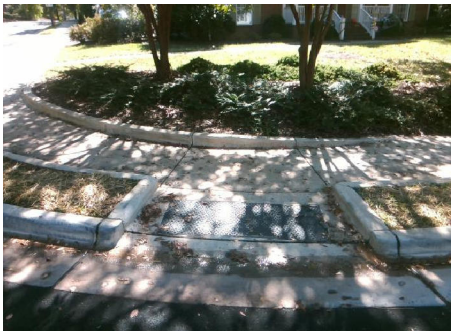
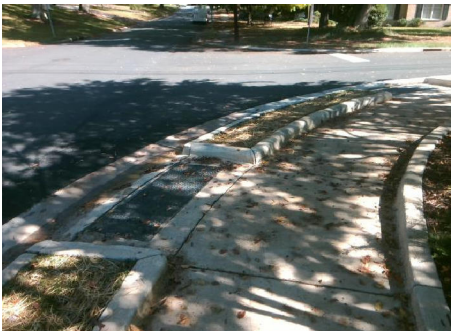
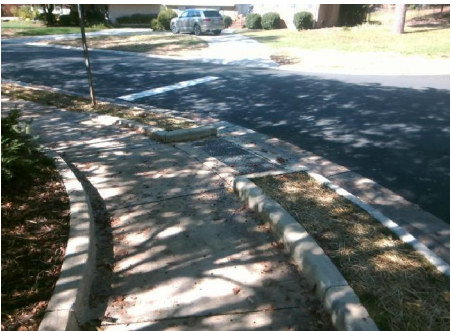
Possible Solutions:			Compliance	Description	Data	Compliance	Description	Data
	Remove & Replace Entire Ramp.			N/A	Ramp Length LT (in)	60.0	N/A	Ramp Length RT (in)	N/A
				Yes	Ramp Width LT (in)	58.0	N/A	Ramp Width RT (in)	N/A
				No	Ramp Slope LT (%)	8.7	N/A	Ramp Slope RT (%)	N/A
				Yes	Ramp XSlope LT (%)	1.1	N/A	Ramp XSlope RT (%)	N/A
				N/A	Ramp Length (in)	36.0	Yes	Ramp Slope (%)	7.2
				Yes	Ramp Width (in)	75.0	No	Ramp XSlope (%)	4.3
	Surveyor Notes:			N/A	Flare Type LT	N/A	N/A	Flare Type RT	N/A
	N/A			N/A	Flare Slope LT (%)	N/A	N/A	Flare Slope RT (%)	N/A
				N/A	Flare Traversable LT?	N/A	N/A	Flare Traversable RT?	N/A
PROW/ADA:				N/A	Landing Length (in)	N/A	N/A	DWS Provided?	N/A
Not Found, R304.5.3, R304.3.2				N/A	Landing Width (in)	N/A	N/A	DWS Contrast?	N/A
				N/A	Landing Slope (%)	N/A	N/A	DWS Length (in)	N/A

N/A	Landing X Slope (%)	N/A	N/A	DWS Full Width?	N/A
				N/A	Landing Curb? (Y/N)	N/A	N/A	DWS Offset (in)	N/A
				N/A	Shared Landing?	N/A			
				N/A	Gutter Ponding?	N/A	N/A	Gutter Slope (%)	N/A
				N/A	Gutter Lip Ht (in)	N/A	N/A	Gutter X Slope (%)	N/A
				N/A	Painted X Walk1?	No	N/A	Painted X Walk2?	N/A
					X Walk 1 Direction	To W		X Walk 2 Direction	N/A
					X Walk 1 Width (in)	N/A		X Walk 2 Width (in)	N/A
					X Walk 1 Slope (%)	4.9		X Walk 2 Slope (%)	N/A
					X Walk 1 X Slope (%)	3.9		X Walk 2 X Slope (%)	N/A
				N/A	Ramp inside XWalk1?	N/A	N/A	Ramp inside XWalk2?	N/A
					Road Slope (%)	N/A		Clear Space?	N/A
					Road X Slope (%)	N/A	N/A	Clear Space to XWalk (in)	N/A
							N/A	Any Obstruction?	N/A
								Obstruction Type	N/A
							N/A	Storm Grate/Utility Hazard?	N/A
								Storm Grate/Utility Type	N/A
									N/A
							Yes	Surface Condition? (G/P)	Good
								Curb Slope (%)	11.1
<div><div>
