# Access Compliance Report

## Public Rights-of-Way

### (Curb Ramps)

| Intersection ID: 10029979 | Main Street: LAMPLIGHTER_PL | Cross Street: N/A | Location: S |

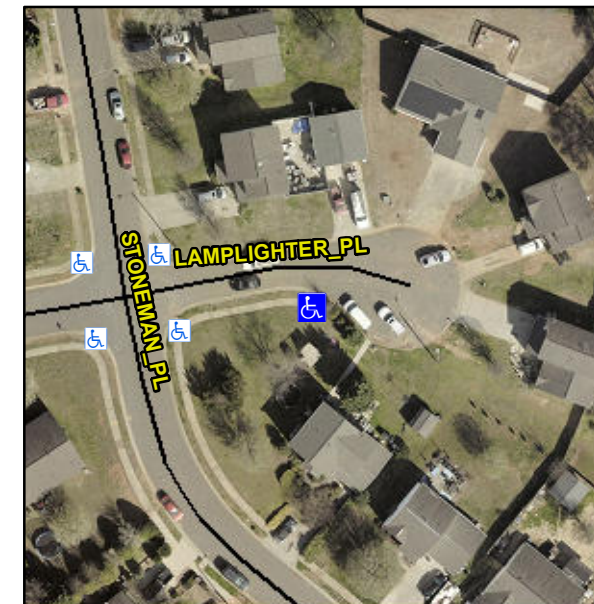
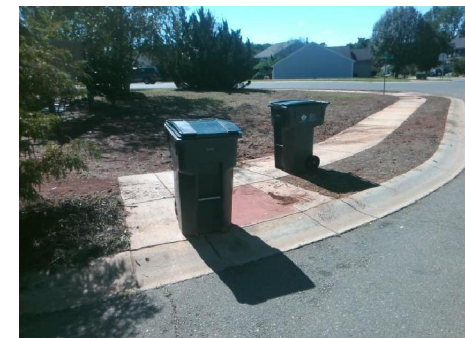
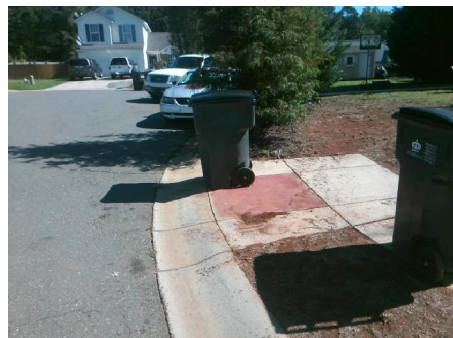
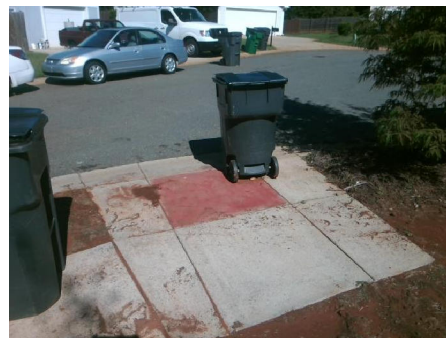
| ADA ID: C2BBED41F061 | Ramp Type: BlendTrans2 | Initial Pass/Fail: Fail | Overall Compliance: No |

**Not Found, R304.5.1, R304.5.3**

| Compliance | Description | Data | Compliance | Description | Data |
|---|---|---|---|---|---|
| No | Ramp Width (in) | 41.0 | No | BlendTrans XSlope (%) | 5.2 |
| | | | No | Curb Slope (%) | 8.7 |

**Remove & Replace Curb Ramp With Two New Directional Ramps or Equivalent.**
