Access Compliance Report Public Rights-of-Way (Curb Ramps)

Intersection ID: 48374Main Street: REDBUD_STCross Street: TATE_STLocation:NEADA ID: C2D3FE5C085BRamp Type: ParaInitial Pass/Fail: PassOverall Compliance: NoSeverity Score: 15.25

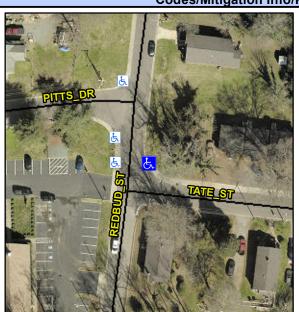
LT RP < 5%

Not Found, R304.5.3, R304.2.1,
R305, R304.5.4

Comp	liance Description	Data	Comp	liance Description	Data
N/A	Ramp Length LT (in)	60.5	N/A	Ramp Length RT (in)	62.5
Yes	Ramp Width LT (in)	60.5	Yes	Ramp Width RT (in)	60.0
Yes	Ramp Slope LT (%)	2.7	Yes	Ramp Slope RT (%)	7.9
No	Ramp XSlope LT (%)	2.1	Yes	Ramp XSlope RT (%)	1.7
Yes	Landing Length (in)	60.0	No	DWS Provided?	No
No	Landing Width (in)	38.0	N/A	DWS Contrast?	No
Yes	Landing Slope (%)	1.5	N/A	DWS Length (in)	N/A
Yes	Landing X Slope (%)	2.3	N/A	DWS Full Width?	No
N/A	Landing Curb? (Y/N)	No	N/A	DWS Offset (in)	N/A
N/A	Shared Landing?	No			
Yes	Gutter Ponding?	No	No	Gutter Slope (%)	10.0
Yes	Gutter Lip Ht (in)	0.0	No	Gutter X Slope (%)	4.2
N/A	Painted X Walk1?	No	N/A	Painted X Walk2?	N/A
	X Walk 1 Direction	To W		X Walk 2 Direction	N/A
N/A	X Walk 1 Width (in)	N/A	N/A	X Walk 2 Width (in)	N/A
	X Walk 1 Slope (%)	1.0		X Walk 2 Slope (%)	N/A
	X Walk 1 X Slope (%)	2.4		X Walk 2 X Slope (%)	N/A
N/A	Ramp inside XWalk1?	N/A	N/A	Ramp inside XWalk2?	N/A

Road Slope (%)	N/A	N/A	Clear Space?	Yes
	Road X Slope (%)	N/A	N/A	Clear Space to XWalk (in)	N/A
Yes	Any Obstructions?	No	Yes	Storm Grate/Utility Hazard?	No
	Obstruction Type			Storm Grate/Utility Type	
		N/A			N/A
			Yes	Surface Condition? (G/P)	Good
			Replace Curb Siloppe (%)

Remove & Replace Entire Ramp.
Remove & Replace Gutter.
