Access Compliance Report Public Rights-of-Way (Curb Ramps)

Intersection ID: 52451Main Street:MOSS_LNCross Street:DOUBLE_OAKS_RDLocation:NEADA ID: C344F38524E7Ramp Type:PerpInitial Pass/Fail:FailOverall Compliance:NoSeverity Score:13.75

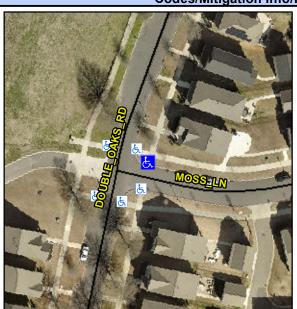
Field Measurements/Component Compliance						
Comp	liance Description	Data	Comp	liance Description	Data	
N/A	Ramp Length (in)	97.0	No	Ramp Slope (%)	11.2	
Yes	Ramp Width (in)	68.0	No	Ramp XSlope (%)	2.5	
N/A	Flare Type LT	N/A	N/A	Flare Type RT	N/A	
N/A	Flare Slope LT (%)	N/A	N/A	Flare Slope RT (%)	N/A	
N/A	Flare Traversable LT?	N/A	N/A	Flare Traversable RT?	N/A	
N/A	Landing Length (in)	N/A	N/A	DWS Provided?	N/A	
N/A	Landing Width (in)	N/A	N/A	DWS Contrast?	N/A	
N/A	Landing Slope (%)	N/A	N/A	DWS Length (in)	N/A	
N/A	Landing X Slope (%)	N/A	N/A	DWS Full Width?	N/A	
N/A	Landing Curb? (Y/N)	N/A	N/A	DWS Offset (in)	N/A	
N/A	Shared Landing?	N/A				
N/A	Gutter Ponding?	N/A	N/A	Gutter Slope (%)	N/A	
N/A	Gutter Lip Ht (in)	1.0	N/A	Gutter X Slope (%)	N/A	
N/A	Painted X Walk1?	No	N/A	Painted X Walk2?	N/A	
	X Walk 1 Direction	To S		X Walk 2 Direction	N/A	
N/A	X Walk 1 Width (in)	N/A	N/A	X Walk 2 Width (in)	N/A	
	X Walk 1 Slope (%)	2.9		X Walk 2 Slope (%)	N/A

X Walk 1 X Slope (%)	3.8		X Walk 2 X Slope (%)	N/A	
N/A	Ramp inside XWalk1?	N/A	N/A	Ramp inside XWalk2?	N/A	
	Road Slope (%)	N/A	N/A	Clear Space?	N/A	
	Road X Slope (%)	N/A	N/A	Clear Space to XWalk (in)	N/A	
N/A	Any Obstructions?	N/A	N/A	Storm Grate/Utility Hazard?	N/A	
	Obstruction Type			Storm Grate/Utility Type		
		N/A			N/A	
			Yes	Surface Condition? (G/P)	Good

russible sululiuli	
Possible Solutions:	Com
Remove & Replace Entire Ramp.	N/A
•	Yes
	N/A
	N/A
	N/A
	N/A
Surveyor Notes:	N/A
N/A	N/A
	N/A
	N/A
	N/A
PROW/ADA:	N/A
R304.2.2, R304.5.3	N/A
,	N/A
	N/A
	N/A
