Access Compliance Report

Public Rights-of-Way

(Curb Ramps)

Intersection ID: 10037305	Main Street: SARDIS_RD	Cross Street: N/A	Location: SW
ADA ID: C37A9EC342A3	Ramp Type: Combination1Diag	Initial Pass/Fail: Fail	Overall Compliance: No
		Severity Score: 0

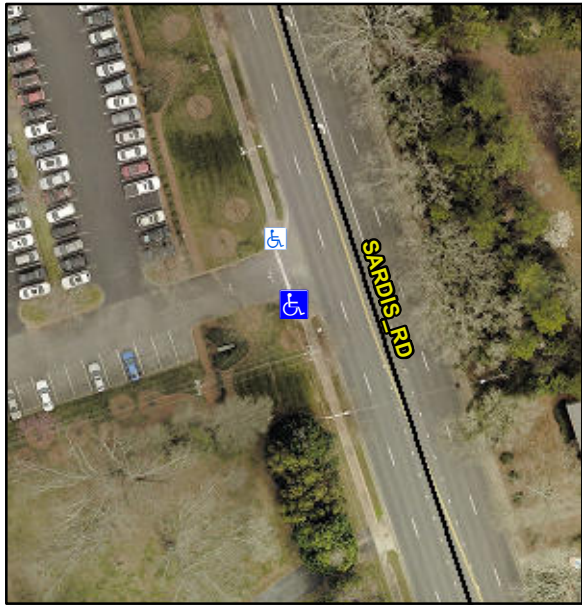
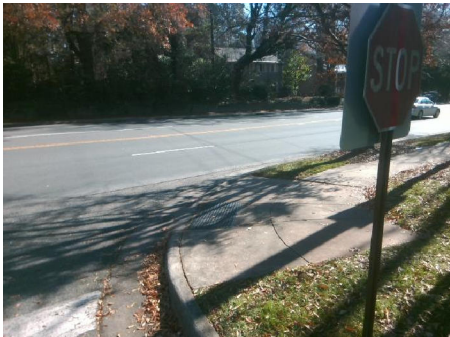
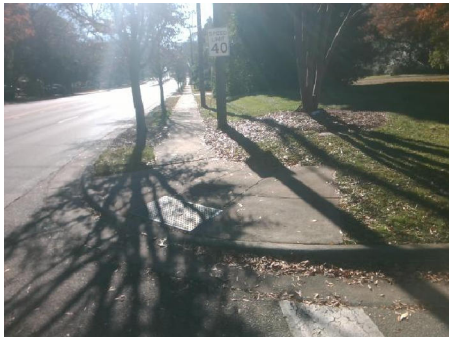
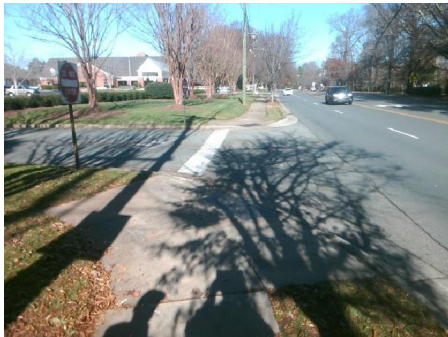
Possible Solutions:			Compliance	Description	Data	Compliance	Description	Data
	Remove & Replace Curb Ramp With Two New Directional Ramps or Equivalent.			N/A	Ramp Length LT (in)	46.0	N/A	Ramp Length RT (in)	36.0
				Yes	Ramp Width LT (in)	58.0	Yes	Ramp Width RT (in)	60.0
				Yes	Ramp Slope LT (%)	3.4	Yes	Ramp Slope RT (%)	6.8
				Yes	Ramp XSlope LT (%)	1.8	Yes	Ramp XSlope RT (%)	0.8
				N/A	Ramp Length (in)	47.0	Yes	Ramp Slope (%)	6.4
				No	Ramp Width (in)	37.0	No	Ramp XSlope (%)	3.0
	Surveyor Notes:			N/A	Flare Type LT	N/A	N/A	Flare Type RT	N/A
	LT RP < 5%			N/A	Flare Slope LT (%)	N/A	N/A	Flare Slope RT (%)	N/A
				N/A	Flare Traversable LT?	N/A	N/A	Flare Traversable RT?	N/A
PROW/ADA:			N/A	Landing Length (in)	N/A	N/A	DWS Provided?	N/A	
Not Found, R304.5.1, R304.5.3			N/A	Landing Width (in)	N/A	N/A	DWS Contrast?	N/A

N/A	Landing Slope (%)	N/A	N/A	DWS Length (in)	N/A	
			N/A	Landing X Slope (%)	N/A	N/A	DWS Full Width?	N/A	
			N/A	Landing Curb? (Y/N)	N/A	N/A	DWS Offset (in)	N/A	
			N/A	Shared Landing?	N/A				
			N/A	Gutter Ponding?	N/A	N/A	Gutter Slope (%)	N/A	
			N/A	Gutter Lip Ht (in)	N/A	N/A	Gutter X Slope (%)	N/A	
			N/A	Painted X Walk1?	No	N/A	Painted X Walk2?	No	
				X Walk 1 Direction	To NW		X Walk 2 Direction	To NW	
				X Walk 1 Width (in)	N/A		X Walk 2 Width (in)	N/A	
				X Walk 1 Slope (%)	0.8		X Walk 2 Slope (%)	4.9	
				X Walk 1 X Slope (%)	4.3		X Walk 2 X Slope (%)	0.3	
Total Cost:			\$ 3200.00	N/A	Ramp inside XWalk1?	N/A	N/A	Ramp inside XWalk2?	N/A
					Road Slope (%)	2.6		Clear Space?	N/A
					Road X Slope (%)	3.3	N/A	Clear Space to XWalk (in)	N/A
						N/A	Any Obstruction?	N/A	
							Obstruction Type	N/A	
						N/A	Storm Grate/Utility Hazard?	N/A	
							Storm Grate/Utility Type	N/A	
						Yes	Surface Condition? (G/P)	Good

Curb Slope (%)	6.9	
								</
