# Access Compliance Report

## Public Rights-of-Way

### (Curb Ramps)

| Intersection ID: 48473 | Main Street: VOELTZ_DR | Cross Street: AUTUMN_OAK_DR | Location: NE |

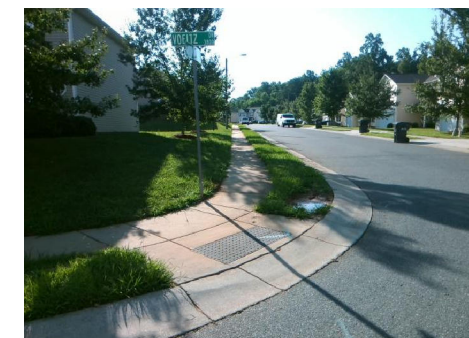
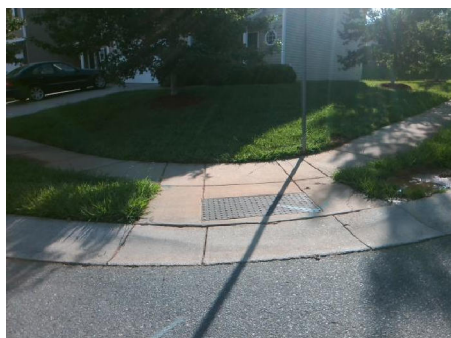
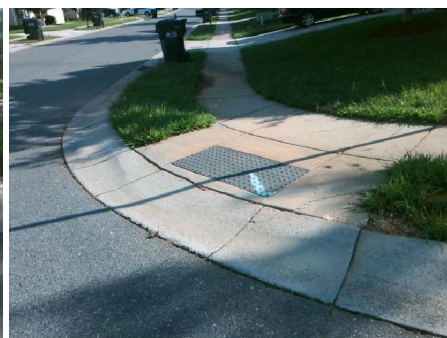
| ADA ID: C3AD561F8073 | Ramp Type: PerpDiag | Initial Pass/Fail: Fail | Overall Compliance: No |
| Severity Score: 35 | | | |

**Not Found, R304.5.1, R304.2.2, R304.5.3**

| Compliance | Description | Data | Compliance | Description | Data |
|---|---|---|---|---|---|
| N/A | Ramp Length (in) | 48.0 | No | Ramp Slope (%) | 12.2 |
| No | Ramp Width (in) | 46.0 | No | Ramp XSlope (%) | 3.1 |

**Remove & Replace Curb Ramp With Two New Directional Ramps or Equivalent.**

Total Cost: \$ 3200.00
