Access Compliance Report

Public Rights-of-Way

(Curb Ramps)

Intersection ID: 50321	Main Street: BELMAR_PLACE_RD	Cross Street: CINDY_LN	Location: SW
ADA ID: C3B3C3777A95	Ramp Type: Directional1	Initial Pass/Fail: Fail	Overall Compliance: No
		Severity Score: 12.5

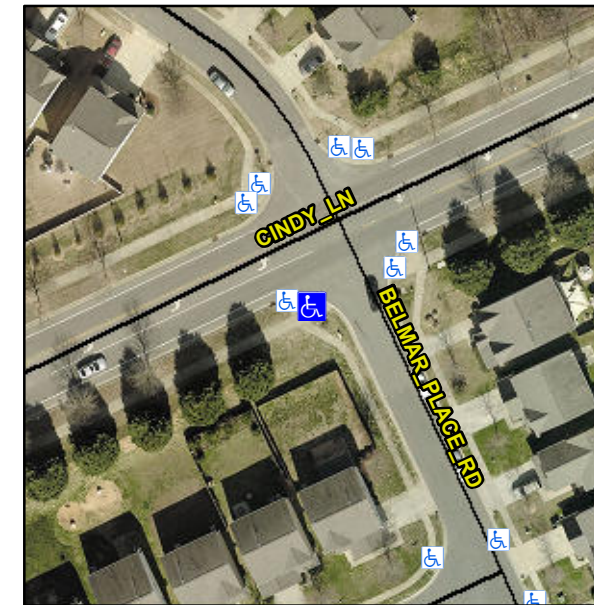
R304.2.2

Compliance	Description	Data	Compliance	Description	Data
N/A	Ramp Length (in)	112.0	N/A	Grade Break?	N/A
Yes	Ramp Width (in)	69.5	N/A	Grade Break Slope (%)	0.0
No	Ramp Slope (%)	10.7	N/A	Grade Break XSlope (%)	0.0
Yes	Ramp XSlope (%)	1.9			
N/A	Flare Type LT	N/A	N/A	Flare Type RT	N/A
N/A	Flare Slope LT (%)	N/A	N/A	Flare Slope RT (%)	0.0
N/A	Flare Traversable LT?	N/A	N/A	Flare Traversable RT?	N/A
N/A	Landing Length (in)	0.0	N/A	DWS Provided?	N/A
N/A	Landing Width (in)	0.0	N/A	DWS Contrast?	N/A
N/A	Landing Slope (%)	0.0	N/A	DWS Length (in)	N/A
N/A	Landing X Slope (%)	0.0	N/A	DWS Full Width?	N/A
N/A	Landing Curb? (Y/N)	N/A	N/A	DWS Offset LT (in)	N/A
N/A	Shared Landing?	N/A	N/A	DWS Offset RT (in)	N/A
N/A	Gutter Ponding?	0.0	N/A	Gutter Slope (%)	N/A
N/A	Gutter Lip Ht (in)	0.0	N/A	Gutter X Slope (%)	N/A
N/A	Painted X Walk1?	No		Road Slope (%)	3.5
	X Walk 1 Direction	To E		Road X Slope (%)	6.1
	X Walk 1 Width (in)	N/A		Clear Space?	N/A

X Walk 1 Slope (%)	3.5	N/A	Clear Space to XWalk (in)	N/A
	X Walk 1 X Slope (%)	6.1	N/A	Storm Grate/Utility Hazard?	N/A
N/A	Ramp inside XWalk1?	N/A		Storm Grate/Utility Type	
N/A	Any Obstructions?	N/A			N/A
	Obstruction Type		Yes	Surface Condition? (G/P)	Good
			N/A	Curb Slope (%)	17.8

Remove & Replace Entire Ramp.
