# Access Compliance Report

## Public Rights-of-Way

### (Curb Ramps)

| Intersection ID: 52442 | Main Street: WOODWARD_AV | Cross Street: BENDING_BIRCH_PL | Location: SE |

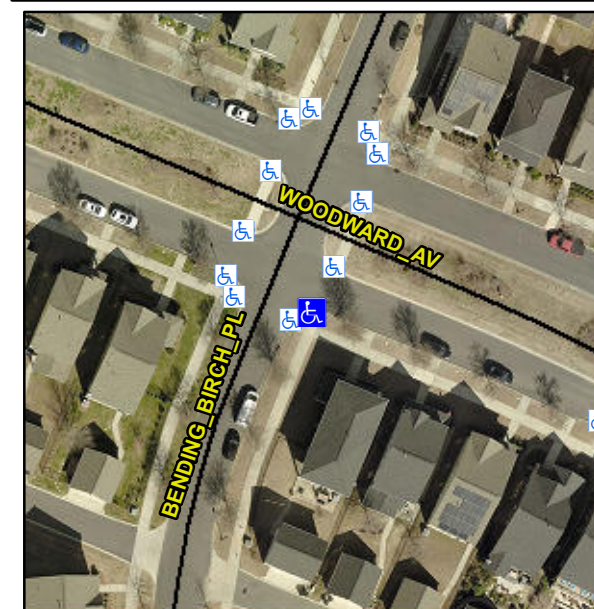
**R304.5.3, R304.2.2-Perp, R304.3.2-  
Para, R305.2, R302.7.2**

| Compliance | Description | Data | Compliance | Description | Data |
|---|---|---|---|---|---|
| No | Ramp XSlope (%) | 4.1 | | | |
| No | Landing Slope (%) | 2.1 | Yes | DWS Length (in) | 24.0 |
| No | Landing X Slope (%) | 4.2 | Yes | DWS Full Width? | Yes |
| No | Gutter Lip Ht (in) | 2.0 | No | Gutter X Slope (%) | 2.9 |

**Remove & Replace Entire Ramp.  
Remove & Replace Gutter.**
