## **Access Compliance Report Public Rights-of-Way** (Curb Ramps)

Intersection ID: 43114 Main Street: HAMORTON\_PL Cross Street: THE\_PLAZA Location: NW

Severity Score: 21.25 **Overall Compliance: No** ADA ID: C3D8D7712295 Ramp Type: Perp Initial Pass/Fail: Fail

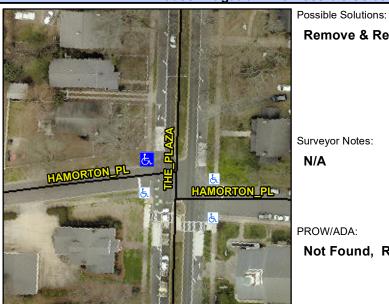
Possible Solutions.	
Remove & Replace Entire Ramp.	N
	N
	N
	N
	N
	N
Surveyor Notes:	N
N/A	N
	N
	N
	N
PROW/ADA:	N
Not Found, R304.5.1, R304.2.2	N
i i	N
	N
•	יז
	N

Field Measurements/Component Compliance								
Comp	liance Description	Data	Compl	iance Description	Data			
N/A	Ramp Length (in)	41.0	No	Ramp Slope (%)	9.1			
No	Ramp Width (in)	43.0	Yes	Ramp XSlope (%)	1.3			
N/A	Flare Type LT	N/A	N/A	Flare Type RT	N/A			
N/A	Flare Slope LT (%)	N/A	N/A	N/A Flare Slope RT (%)				
N/A	Flare Traversable LT?	N/A	N/A	Flare Traversable RT?	N/A			
N/A	Landing Length (in)	N/A	N/A	DWS Provided?	N/A			
N/A	Landing Width (in)	N/A	N/A	DWS Contrast?	N/A			
N/A	Landing Slope (%)	N/A	N/A	DWS Length (in)	N/A			
N/A	Landing X Slope (%)	N/A	N/A	DWS Full Width?	N/A			
N/A	Landing Curb? (Y/N)	N/A	N/A	DWS Offset (in)	N/A			
N/A	Shared Landing?	N/A						
N/A	Gutter Ponding?	N/A	N/A	Gutter Slope (%)	N/A			
N/A	Gutter Lip Ht (in)	N/A	N/A	Gutter X Slope (%)	N/A			
N/A	Painted X Walk1?	No	N/A	Painted X Walk2?	N/A			
	X Walk 1 Direction	To S		X Walk 2 Direction	N/A			
N/A	X Walk 1 Width (in)	N/A	N/A	X Walk 2 Width (in)	N/A
