Access Compliance Report

Public Rights-of-Way

(Curb Ramps)

Intersection ID: 3313	Main Street: PROSPERITY_CHURCH_RD	Cross Street: OLD_TIMBER_RD	Location: NW
ADA ID: C3EB5630BED1	Ramp Type: Para	Initial Pass/Fail: Fail	Overall Compliance: No
		Severity Score: 25

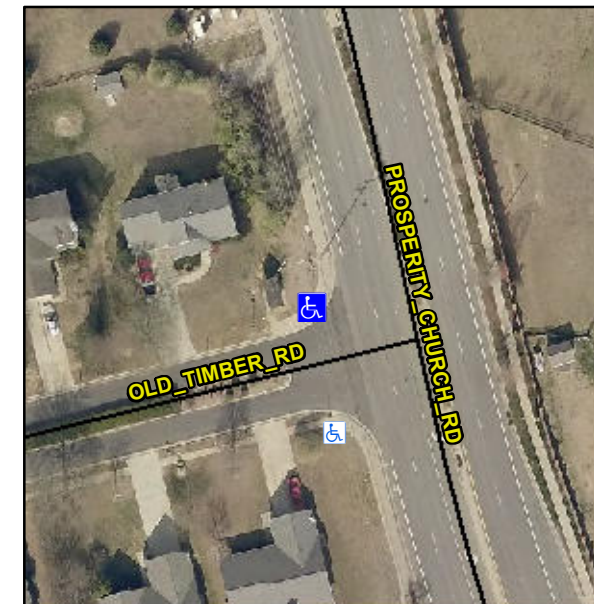
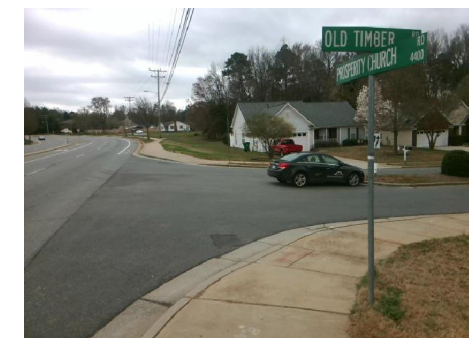
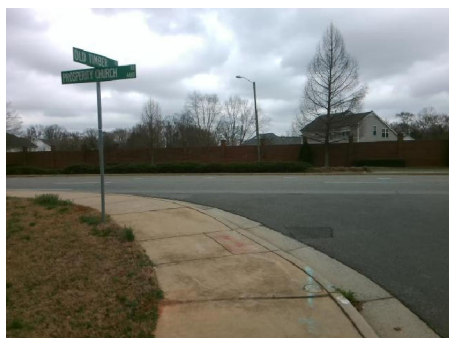
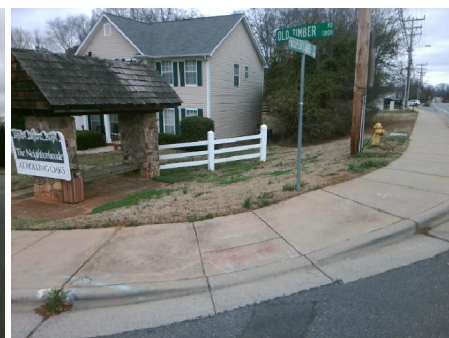
LT RP < 5%

R304.3.2

Compliance	Description	Data	Compliance	Description	Data
N/A	Ramp Length LT (in)	46.5	N/A	Ramp Length RT (in)	58.5
Yes	Ramp Width LT (in)	72.0	Yes	Ramp Width RT (in)	72.0
Yes	Ramp Slope LT (%)	3.7	No	Ramp Slope RT (%)	15.4
Yes	Ramp XSlope LT (%)	2.0	Yes	Ramp XSlope RT (%)	0.5
N/A	Landing Length (in)	N/A	N/A	DWS Provided?	N/A
N/A	Landing Width (in)	N/A	N/A	DWS Contrast?	N/A
N/A	Landing Slope (%)	N/A	N/A	DWS Length (in)	N/A
N/A	Landing X Slope (%)	N/A	N/A	DWS Full Width?	N/A
N/A	Landing Curb? (Y/N)	N/A	N/A	DWS Offset (in)	N/A
N/A	Shared Landing?	N/A			
N/A	Gutter Ponding?	N/A	N/A	Gutter Slope (%)	N/A
N/A	Gutter Lip Ht (in)	N/A	N/A	Gutter X Slope (%)	N/A
N/A	Painted X Walk1?	No	N/A	Painted X Walk2?	N/A
	X Walk 1 Direction	To S		X Walk 2 Direction	N/A
N/A	X Walk 1 Width (in)	N/A	N/A	X Walk 2 Width (in)	N/A
	X Walk 1 Slope (%)	N/A		X Walk 2 Slope (%)	N/A
	X Walk 1 X Slope (%)	N/A		X Walk 2 X Slope (%)	N/A
N/A	Ramp inside XWalk1?	N/A	N/A	Ramp inside XWalk2?	N/A

Remove & Replace Entire Ramp.
