Access Compliance Report

Public Rights-of-Way

(Curb Ramps)

Intersection ID: 12224	Main Street: MILLERTON_AV	Cross Street: FLEETWOOD_DR	Location:	N
ADA ID: C44A208714B9	Ramp Type: Perp	Initial Pass/Fail: Fail	Overall Compliance: No	Severity Score: 8.75

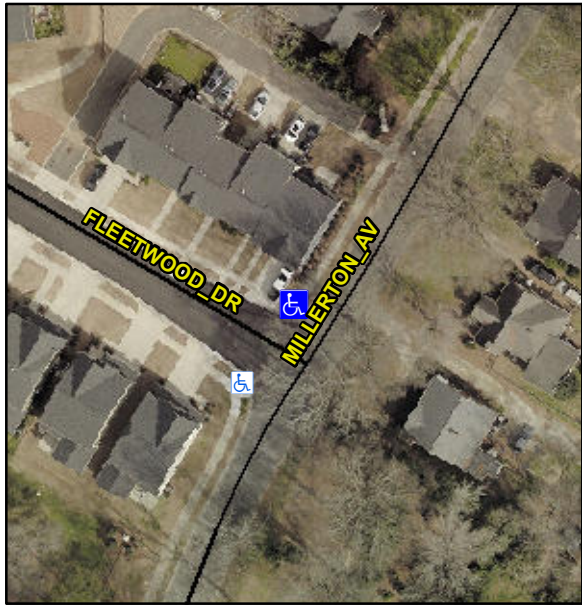
Possible Solutions:		Compliance			Description			Data					
	Remove & Replace Entire Ramp.		N/A	Ramp Length (in)		60.0		Yes	Ramp Slope (%)		8.2			
			No	Ramp Width (in)		46.5		Yes	Ramp XSlope (%)		0.6			
			N/A	Flare Type LT		N/A		N/A	Flare Type RT		N/A			
			N/A	Flare Slope LT (%)		N/A		N/A	Flare Slope RT (%)		N/A			
			N/A	Flare Traversable LT?		N/A		N/A	Flare Traversable RT?		N/A			
			N/A	Landing Length (in)		N/A		N/A	DWS Provided?		N/A			
			N/A	Landing Width (in)		N/A		N/A	DWS Contrast?		N/A			
			N/A	Landing Slope (%)		N/A		N/A	DWS Length (in)		N/A			
			N/A	Landing X Slope (%)		N/A		N/A	DWS Full Width?		N/A			
Surveyor Notes:		N/A			N/A			DWS Offset (in)			N/A			
PROW/ADA:		Not Found, R304.5.1			N/A									
					N/A			Gutter Ponding?			N/A			
					N/A			Gutter Lip Ht (in)			N/A			
					N/A			Painted X Walk1?			No

To SW			X Walk 2 Direction			N/A			
		N/A			N/A			X Walk 2 Width (in)			N/A			
					0.5			X Walk 2 Slope (%)			N/A			
					0.3			X Walk 2 X Slope (%)			N/A			
		N/A			N/A			Ramp inside XWalk2?			N/A			
					N/A			Clear Space?			N/A			
					N/A			Clear Space to XWalk (in)			N/A			
		N/A			N/A			Storm Grate/Utility Hazard?			N/A			
								Storm Grate/Utility Type						
					N/A						N/A			
								Yes			Surface Condition? (G/P)		Good
