# Access Compliance Report

## Public Rights-of-Way

### (Curb Ramps)

| Intersection ID: 48865 | Main Street: TIGRESS_CT | Cross Street: ERWIN_RD | Location: W |

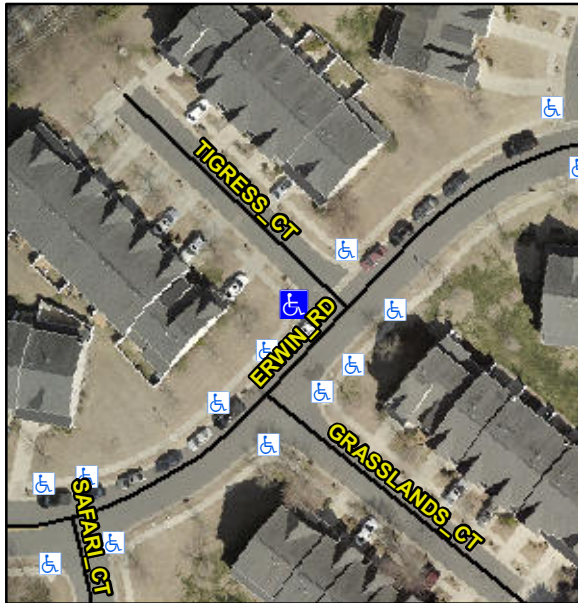
| ADA ID: C4805A6C4DA7 | Ramp Type: PerpDiag | Initial Pass/Fail: Fail | Overall Compliance: No |

**Not Found, R304.2.2, R304.5.3**

| Compliance | Description | Data | Compliance | Description | Data |
|---|---|---|---|---|---|
| N/A | Ramp Length (in) | 48.0 | No | Ramp Slope (%) | 8.7 |
| Yes | Ramp Width (in) | 48.0 | No | Ramp XSlope (%) | 4.3 |

**Remove & Replace Curb Ramp With Two New Directional Ramps or Equivalent.**
