# Access Compliance Report

## Public Rights-of-Way

### (Curb Ramps)

| Intersection ID: 9973 | Main Street: CAMPUS_ST | Cross Street: FRENCH_ST | Location: NW |

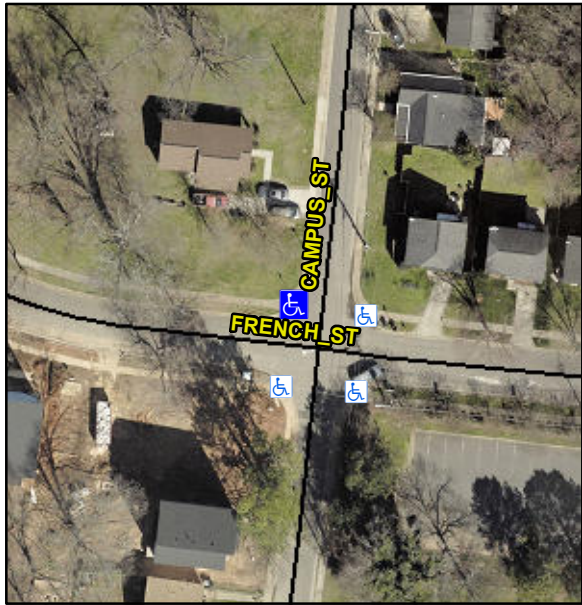
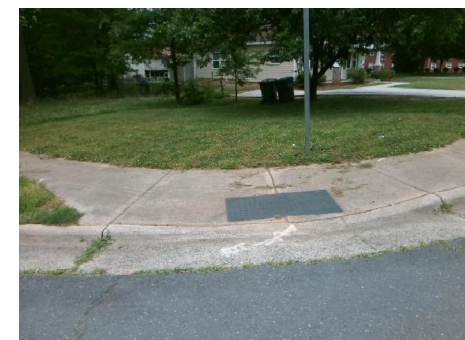
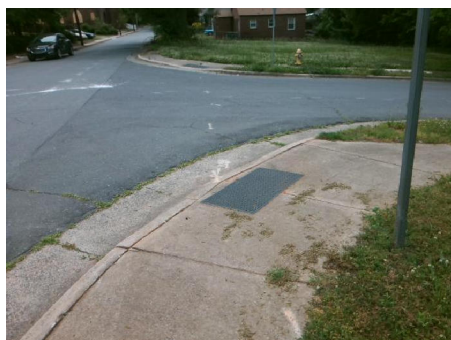
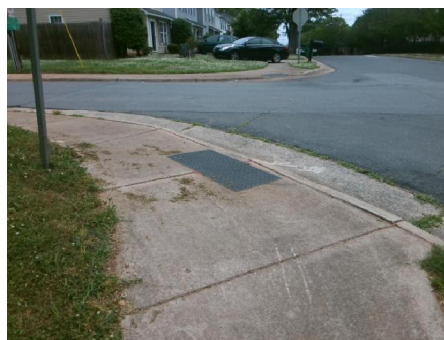
| ADA ID: C4BAB5946E40 | Ramp Type: BlendTrans1 | Initial Pass/Fail: Fail | Overall Compliance: No |
| | | Severity Score: 12.5 | |

| Codes/Mitigation Info/Possible Solution | | | Field Measurements/Component Compliance | | | | | |
|--|--|--|---|---|---|---|---|---|
| | | | Yes | Ramp Width (in) | 48.0 | No | BlendTrans XSlope (%) | 6.0 |
| Not Found, R304.5.3 | | | N/A | Gutter Ponding? | N/A | N/A | Gutter Slope (%) | N/A |
| | | | | | | No | Curb Slope (%) | 22.3 |

| Codes/Mitigation Info/Possible Solution | | | Field Measurements/Component Compliance | | | | | |
|--|--|--|---|---|---|---|---|---|
| | Remove & Replace Curb Ramp With Two New Directional Ramps or Equivalent. | | N/A | Ramp Length (in) | 64.0 | Yes | BlendTrans Slope (%) | 2.5 |
